# EVALUATION AND REHABILITATION OF CONCRETE PIER

By Abdulaziz A. Bubshait,<sup>1</sup> Member, ASCE, and Bassam M. Tahir<sup>2</sup>

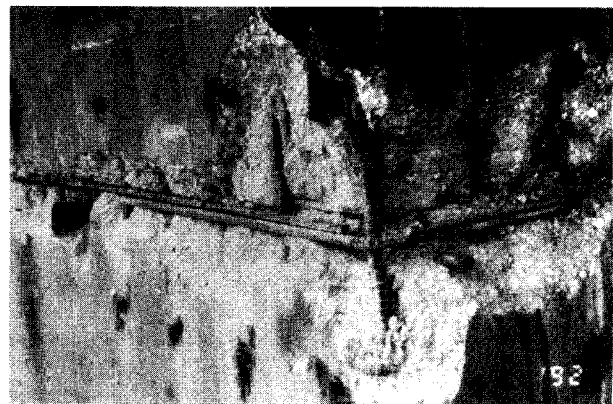
A few years later the pier being studied manifested severe cracking and spalling at the construction joint between its walls and platform due to twisting of the platform as a result of torsional stress. The twist was so significant that most of the vertical reinforcement bars passing through the defective platform/walls joint had been completely sheared, and the platform was left "floating" on the walls (Fig. 1). Diagonal shear cracks were also observed on the walls of the pier, on both exterior and interior surfaces, sometimes penetrating the full thickness of the walls. Some of these cracks were a recurrence of old cracks that had been repaired earlier, and some were new cracks. Fig. 2 shows the details of the pier and distress manifested. The inclined lines on the platform walls indicate the direction of the shear cracks only. For more specific details of the case refer to Tahir (1995).

FIG. 1. Damaged Platform/Walls Joints

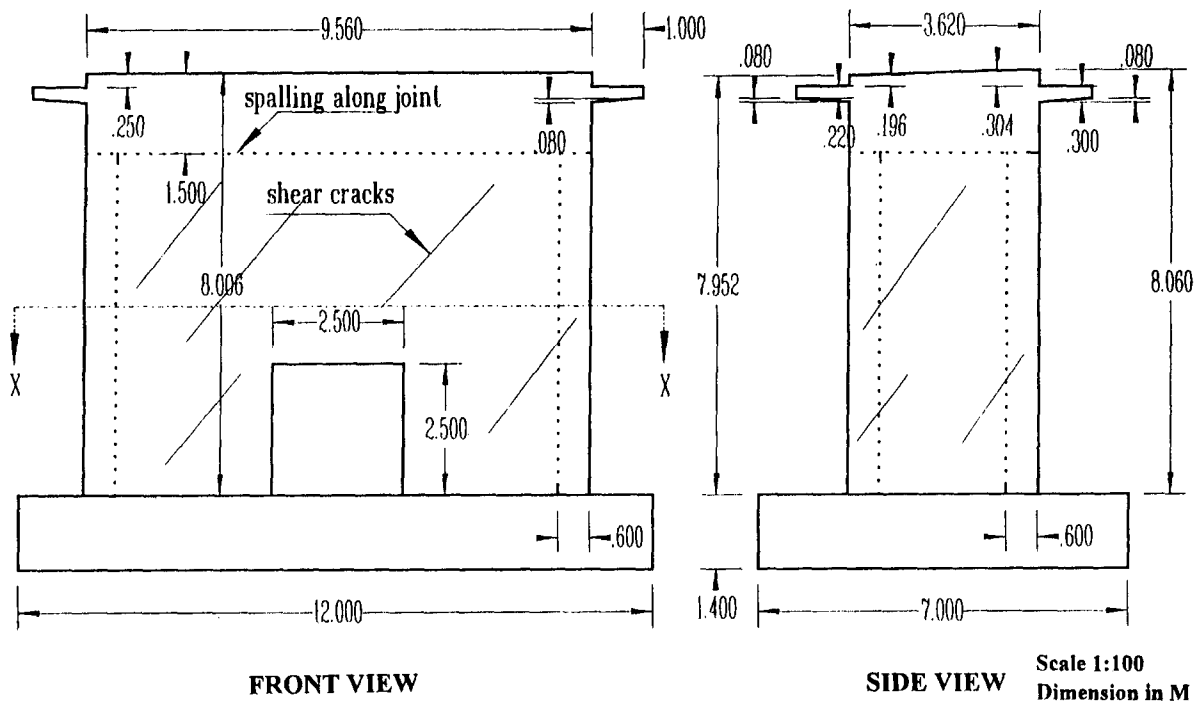
FIG. 2. Details of Pier and Distress Manifested

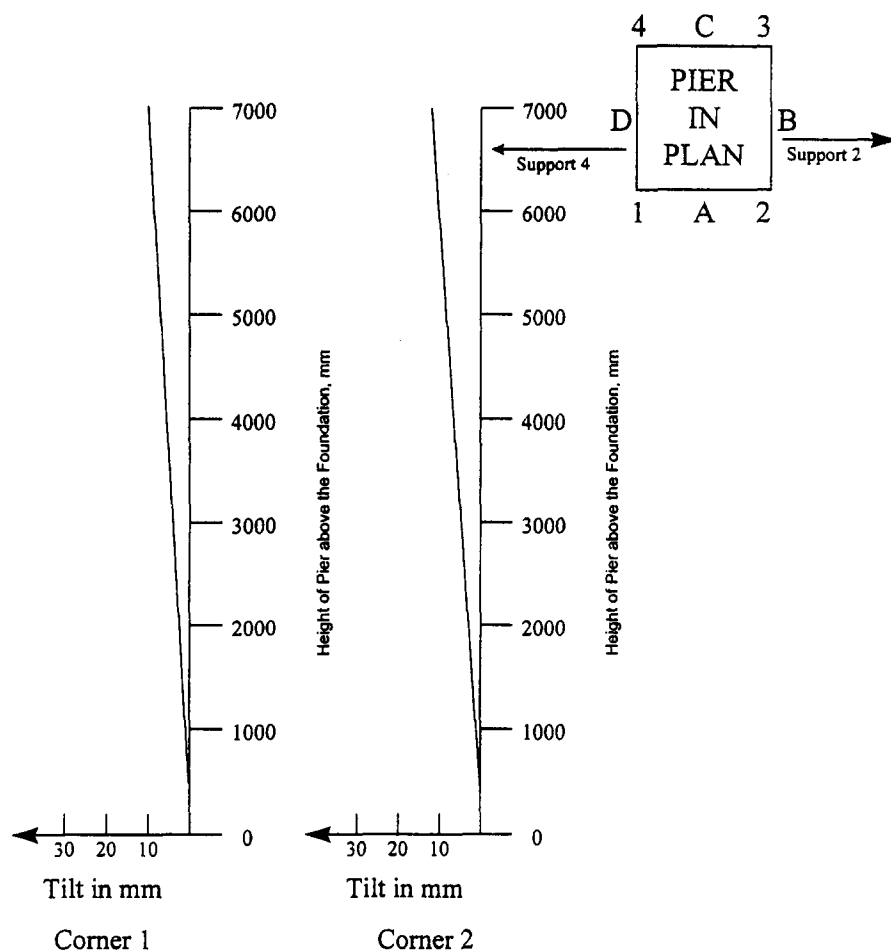
The displacement of the platform corners, from vertical lines projected upward from the corners of the pier, was measured every 1 m. Fig. 3 illustrates the corner displacement. The twist notation used shows the movement as clockwise when viewed from the top of the pier.

FIG. 3. Twist of Pier Observed along Face

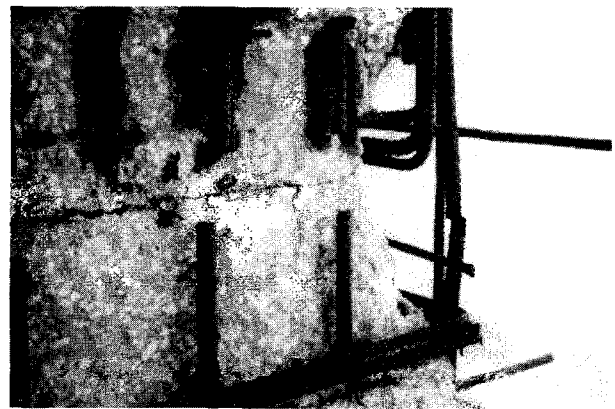
FIG. 4. Southwest Corner of Joint after Chipping of Surrounding Concrete

A 600-mm-wide concrete strip around the platform/walls joint, inside and outside, 300 mm on each side of the joint, or the area of deteriorated concrete, whichever was larger, was removed using chipping hammers to a sufficient depth to provide at least a 25-mm clear gap behind the reinforcement bars (see Fig. 4). Low-mass hammers were used in order to minimize the formation of microcracking and to avoid weakening the surface. Chipped areas were sandblasted in order to completely remove residual fractured fragments on the surface and clear the platform/walls joint.

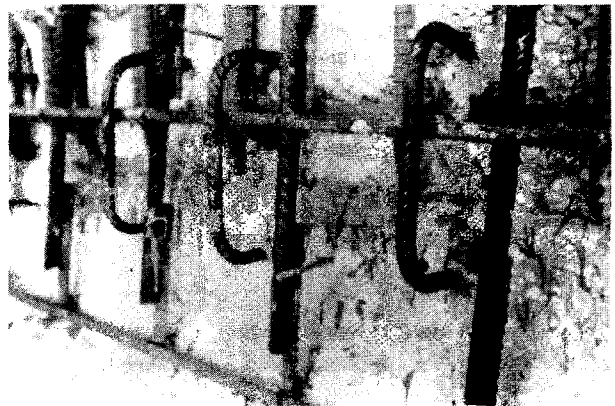
The reinforcement bars exposed were found to be in excellent condition as far as corrosion was concerned. However, approximately two-thirds of the vertical bars passing through the joint were completely sheared due to the torsional stress. The sheared reinforcement bars were restored back to continuity by using lap bars, as shown in Fig. 5.

FIG. 5. Platform/Walls Joint after Installation of Stitching Dogs

As an additional measure to strengthen the joint, the walls and the platform were "stitched" together on the exterior surface with 16-mm, U-shaped reinforcement bars inserted in the concrete to a depth of 200 mm using epoxy grout (Fig. 5). One U-bar was provided at 300-mm by inserting 20-mm bars in the underside of the platform and in the walls around the platform/walls joint and then welding them together. The scheme was then covered with shotcrete around the joint.

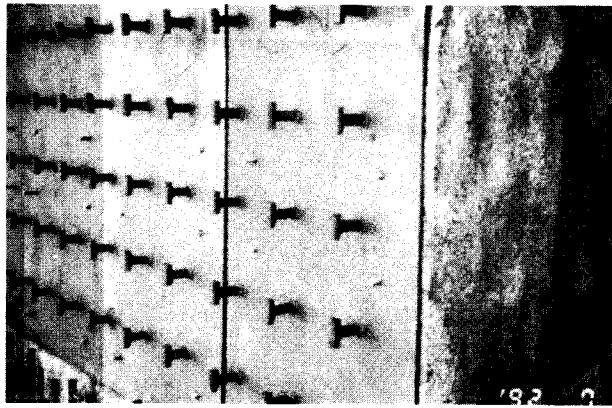
**FIG. 6. Insertion of Chemical Anchors for Installation of Steel Plates**

As an additional measure to further strengthen the platform/walls joint, 8-mm-thick mild steel plates,  $1.2 \times 0.6$  m, were bonded on the concrete surface around the joint as shown in Fig. 6. T-shaped shear connectors were welded on the exterior side of the steel plates before bonding at 200-mm intervals both ways to ensure a proper bond between the plates and the new shotcrete. Bonding to the existing concrete walls was done by using 12-mm-diameter chemical anchors (eight bolts per plate) and epoxy adhesive conforming to ASTM C881-90 Type IV, Class C, Grade 3. To remove any rust, scale, oil, dust, grease, or other impurities that could prevent complete adhesion with concrete, the steel plates were grit-blasted just prior to bonding. Care was taken not to expose the plates after bonding to any disturbance until the adhesive attained its full strength.

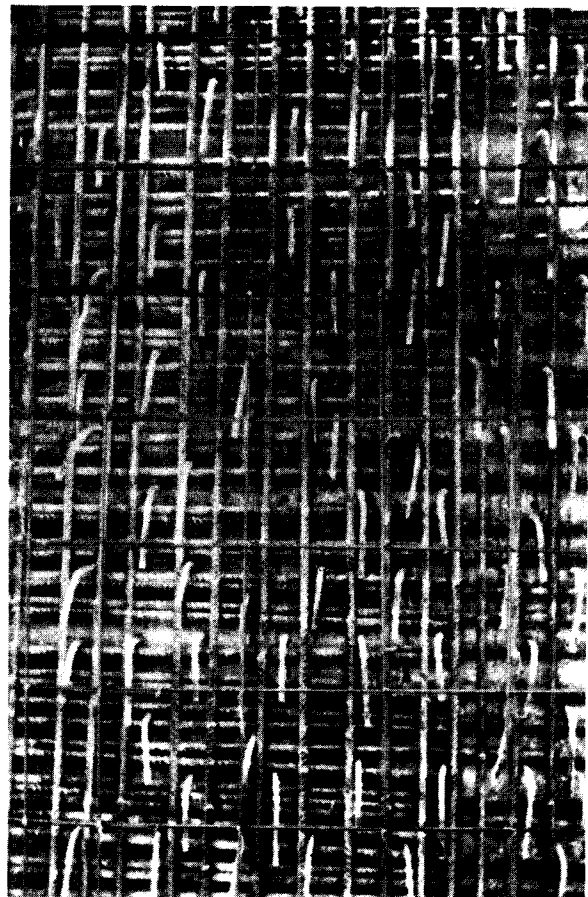
**FIG. 7. Main and Temperature Reinforcement Bars Installed around Pier**

In addition to the main reinforcement, a mesh of 10-mm diameter rebars, at 300-mm intervals both ways, was provided to serve as temperature and shrinkage reinforcement. This reinforcement was placed so that a 50-mm shotcrete cover was maintained. Fig. 7 shows the structure after all reinforcement bars were installed and prior to shotcreting. Intersecting bars were rigidly tied to each other with 16-gauge tie wire and adequately supported to minimize vibration during shotcrete placement. Splices provided for vertical as well as horizontal rebars were approximately 1.2-m-long. This exceeded the maximum requirement as found from splicing calculations.
