DESIGN AND CONSTRUCTION PROBLEMS OF STEEL FORMED DECK FLOORS IN STEEL BUILDINGS

Abdulaziz M. Al-Hamad

Some design construction problems related to steel formed deck and concrete slab floors in steel buildings built in Dammam, Saudi Arabia are presented. Their description and effects on building performance in daily use and possible causes are discussed.

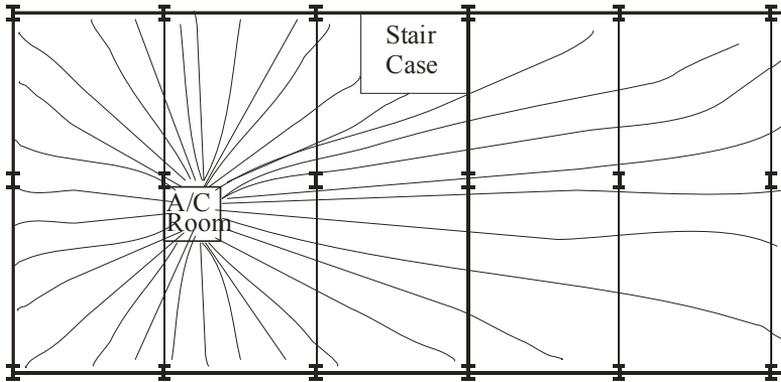
(a) Cracks pattern in the concrete layer of the mezzanine floor due to one unit.

Figure (3) Cracks in non-reinforced concrete layer due to air handling units vibrations.

In the first inspected building, the absence of concrete layer reinforcement coupled with poor isolation of HVAC equipment (i.e., air handling units) and use of smooth formed steel sheets (as opposed to embossed or indented sheets) subjected the concrete layer to severe cracks in

the whole floor area. These cracks had a radial pattern having its center at the HVAC equipment location. They were most severe in both size and concentration near the HVAC equipment and became less frequent and smaller as the distance from the HVAC unit increased. Since the floor has two HVAC units located towards the opposite ends of the building, there were two patterns of cracks radiating from the locations of those two units, and crossing at the middle area of the building, Figure (3-a). The cracks also followed the paths of conduits for electrical wiring embedded in the concrete layer.

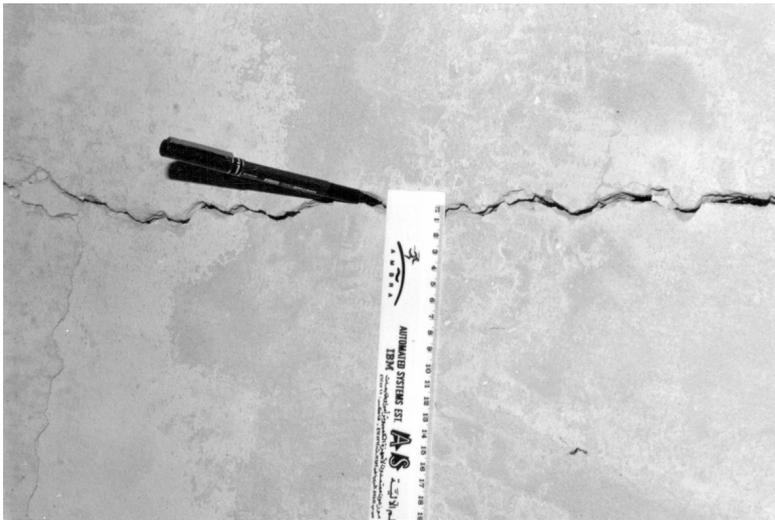
(b) Major crack in the concrete layer.

These cracks divided the concrete slab into discrete blocks that were in continuous movement against their adjacent blocks. Continuous floor vibration caused grinding and some loss of interlocking between these concrete blocks, leading to further deterioration and increased crack widths with depth equal to the full slab depth. Crack widths up to 8 mm at the slab surface were measured in the areas near the HVAC units, Figure (3-b).

As a result, the floor stiffness decreased, and its response to vibrations was governed mainly by the stiffness of the steel beams and formed steel sheets. Decreased stiffness caused the floor to become more resonant to the induced vibrations and increased vibrations magnitude. This follows basic dynamics, where the floor vibration increases as its stiffness decreases. Occupants began to notice these vibrations with time, and eventually felt uncomfortable with them and complain about them. Such noticeable vibrations were more distracting and annoying in quiet office settings where legs of chairs vibrated noticeably. This situation may be categorized as “easily perceptible” [Vannoy and Heins, 1979].

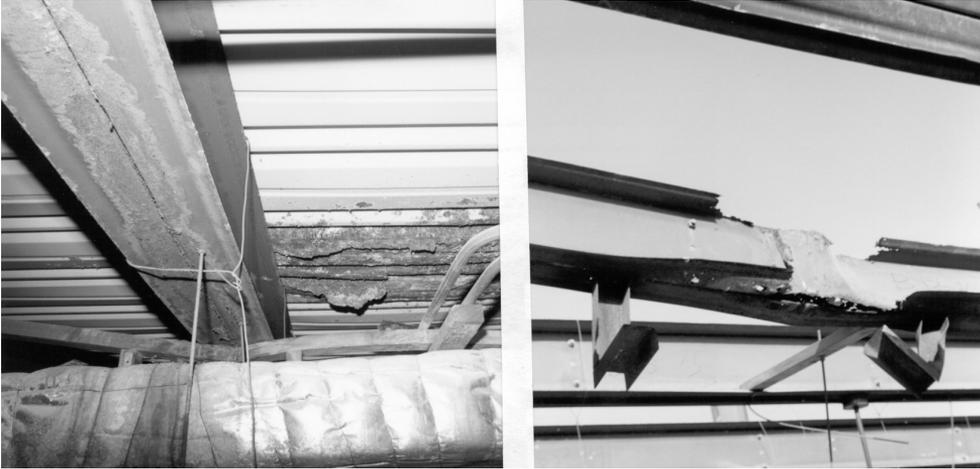
This problem was noticed mainly in the floor bays under HVAC equipment in the upper floor level of the second building (with slab reinforcement). The excessive deflection caused water leakage from the unit assembly to accumulate at the center of the floor underneath it. The accumulated water seeped through the concrete layer, and with passage of time, it caused severe corrosion of the steel sheet and the two middle joists. Severity of corrosion completely consumed the upper flanges and most of the web of these joists, Figure (4), causing loss of their strength; this in turn increased the floor deflection. Sheet corrosion is illustrated in Figures (4) and (5).

Figure (4) Corrosion of steel joist before (left) and after dismantling the floor (right).

Permanent slab deflection measured after removal of the equipment was 70 mm over a span of 7 m. This large deflection caused visible cracks at the top of the concrete layer at the edges of the slab under discussion. When the building was dismantled, the two middle joists under each of the two HVAC units on the floor were the only joists that fell apart and hanged from their ends.

The cause for initial excessive deflection may be attributed to neglecting the special design considerations for the equipment heavy weight and its impact loads; the floors under HVAC equipment had the same structural design as the rest of the buildings. In addition, poor isolation of the equipment increased the effect of the unit vibrations on the floor.

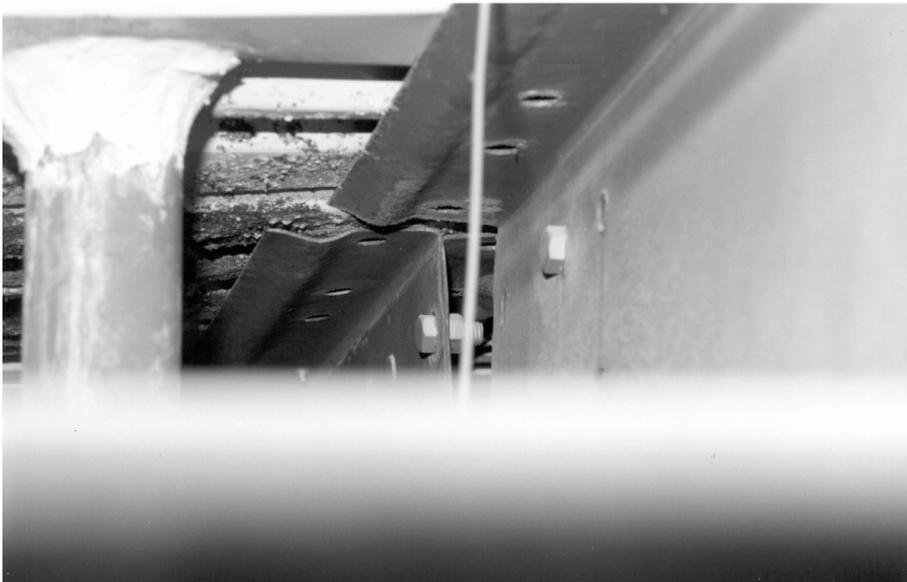
Figure (5) Relative movement of floor at the line above the middle girder.

Another problem that was noticed in the second building was the relative movement of the slabs in the two adjacent bays -extending across the building- against each other, where the concrete slab was separated along a line extending above the middle girder. This movement may be due to one or more of the following several factors. First, the joists were erected above the girders, as illustrated in Figure (2-b) above. Second, the joists were constructed of two cold-formed channel sections, connected back-to-back by two lines of bolts across the joist height. These bolts were low grade ones with simple tightening (i.e., no pretensioning which produces friction resistance), allowing the channels to easily move against each other when subjected to lateral loads perpendicular to its axis. In other words, this type of construction provided weak joist lateral stiffness, allowing relative movement of the joist top flange against its lower flange. As a result, the two sets of joists in the two adjacent bays across the building moved by a distance of about 20 mm, as seen in Figure (5).

Further slab movement may have been prevented by contact between the edge of the slab and the column located at the slab edge, and/or shear force in the bolts joining the two channel sections due to relative slip between the channel sections. Both loads on the column and bolts due to slab movement were not accounted for in the design.
