Degradation of turbine blades and vanes by overheating in a power station

H.M. Tawancy*, Luai M. Al-Hadhrani

Center for Engineering Research, Research Institute, King Fahd University of Petroleum and Minerals, P.O. Box 1639, Dhahran 31261, Saudi Arabia

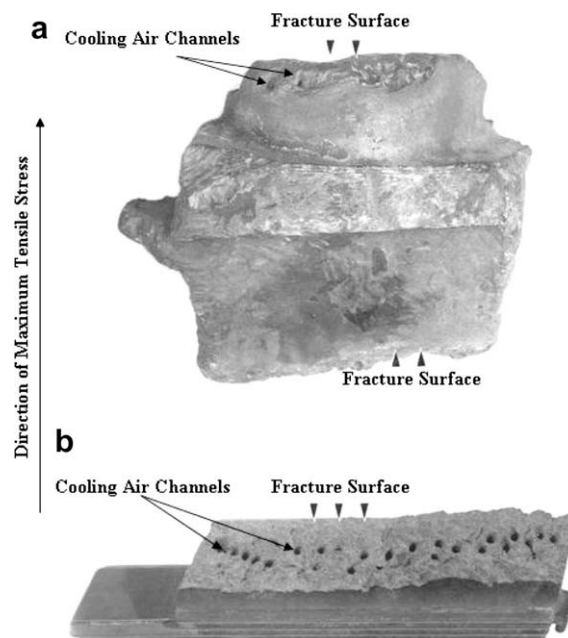
Photographs illustrating characteristic macroscopic features of the damaged blade in the as-received condition are shown in Fig. 1. It is observed that the airfoil was severely distorted and that fracture occurred along two sections normal to the direction of maximum tensile stress. Evidently, fracture was preceded by macroscopic plastic deformation, which could occur by creep suggesting that the blade was exposed to higher than normal temperatures. Distortion of the cooling air channels is noted in Fig. 1b and also in Fig. 2. Another indication that the blade was exposed to higher temperatures was extensive oxidation of the fracture surface as shown in the macrograph of Fig. 2. Usually, oxidation of Ni-based superalloys becomes significant at temperatures ≥ 1000 °C [6].

Fig. 1. Photographs illustrating the fractured blade in the as-received condition. (a) A view of the airfoil showing macroscopic distortion. (b) A view of the lower section of the fracture surface showing the cooling air channels.

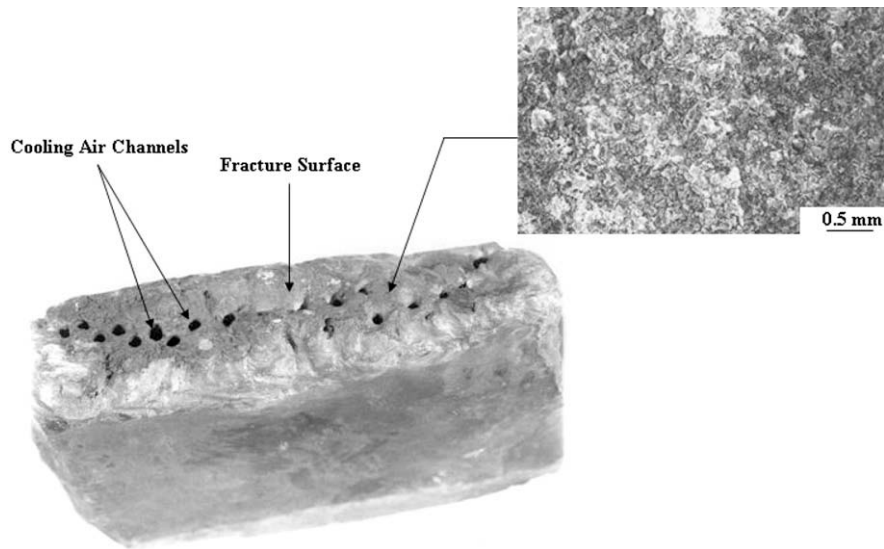
Fig. 2. A photograph showing the lower fracture surface of the blade, and corresponding secondary electron macrograph illustrating the surface oxide layer.

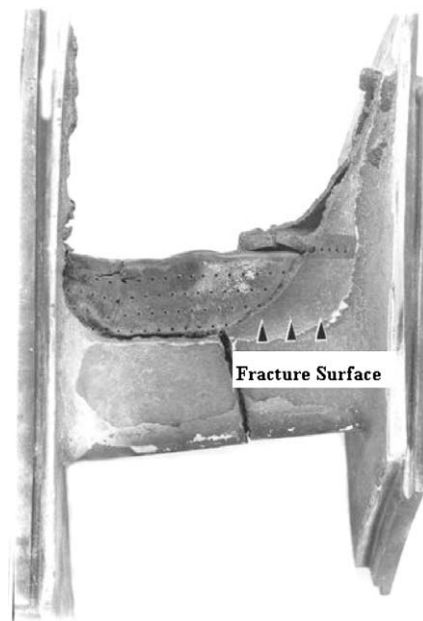
An example illustrating the general appearance of damaged vane is shown in Fig. 3. Similar to the case of blade described above, the surface exposed by fracture of the airfoil was heavily oxidized indicating that the vane was exposed to higher than normal temperatures.

Fig. 3. A photograph showing a general view of the vane and the surface exposed by fracture of the airfoil.

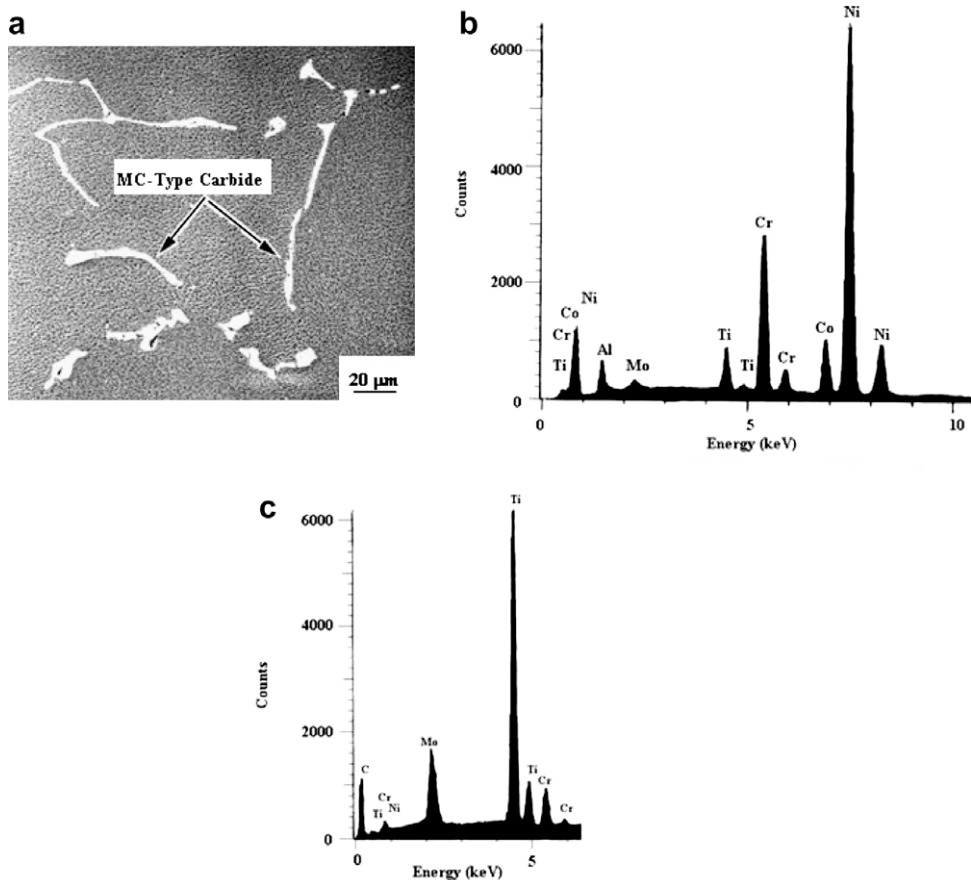
Fig. 4 summarizes characteristic microstructural features of the blade material as observed on the scale of scanning electron microscopy. As expected, the matrix phase contained a dispersion of the strengthening γ' -phase. However, a rather continuous layer of secondary precipitates are observed to delineate the grain boundaries as shown in the backscattered

electron image of Fig. 4a. A typical energy dispersive X-ray spectrum illustrating the elemental composition of the matrix phase is shown in Fig. 4b. Quantification of the spectral data showed that the composition was consistent with that of Udimet alloy 710 as specified. As shown in the spectrum of Fig. 4c, the grain boundary phase appeared to be an MC-type carbide of the form $(\text{Ti}, \text{Mo})\text{C}$ similar to the case of Udimet alloy 500 [7]. A carbide morphology such as that shown in Fig. 4a could have an adverse effect on mechanical strength resulting in embrittlement of the alloy [1]. Secondary intergranular cracks were observed along grain boundaries containing carbide precipitates as shown later.

Fig. 4. Characteristic microstructural features of the blade material in the as-received condition. (a) Backscattered electron image showing a network of grain boundary carbides and the structure of γ' -phase within the matrix. (b) An energy dispersive X-ray spectrum illustrating the elemental composition of the blade alloy. (c) An energy dispersive X-ray spectrum illustrating the elemental composition of the grain boundary carbide.

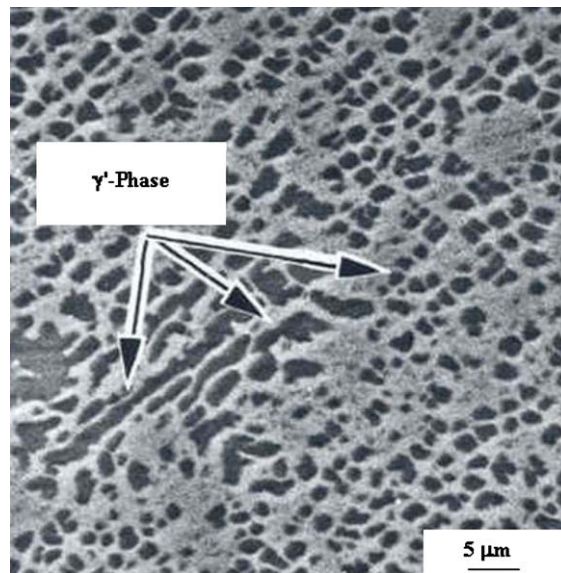
Fig. 5 is a secondary electron SEM image illustrating a representative morphology of the γ' -phase near the major fractures shown in Fig. 1. Agglomeration and elongation or rafting of the γ' -phase are indicative of overheating to a level higher than the γ' -solvus temperature. It is also observed from Fig. 5 that relatively large regions of the matrix phase are free of the γ' -phase. This is further illustrated in the example of Fig. 6 derived in the scanning transmission electron microscopy (STEM) mode of an analytical electron microscope. Fig. 6a is a bright-field STEM image showing a typical microstructure of the γ' -phase at approximately halfway the distance between the two major fractures of Fig. 1. Corresponding microdiffraction pattern derived from a γ' particle (face-centered cubic: L12 superlattice) in $\langle 001 \rangle$ orientation is shown in the inset. It is observed that the cuboidal particles of γ' -phase providing strength at higher temperatures are finer than those near the fracture surface (Fig. 5). Also, the fine spherical particles of γ' -phase providing low-temperature tensile strength are clearly distinguished. Fig. 6b is a bright-field STEM image showing typical rafting of γ' -phase near the major fractures of Fig. 1.

Fig. 5. Backscattered electron image illustrating coarsening and rafting of the γ' -phase in the blade material near the major fractures shown in Fig. 1 (as-received condition).

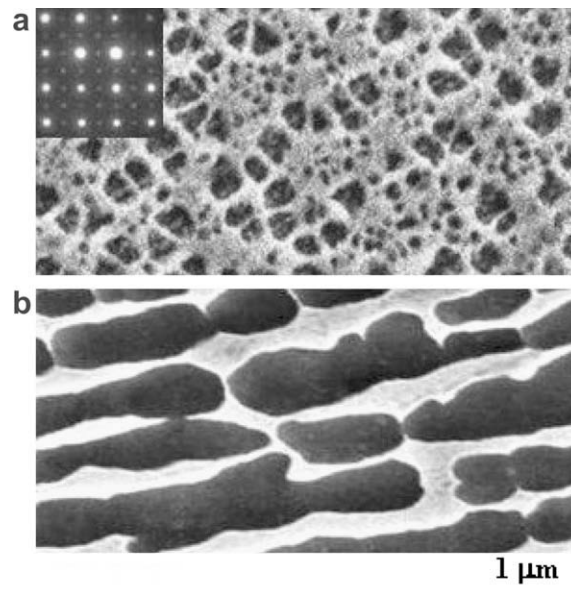
It is evident from the above observations that the blade was subjected to large variations in temperatures as indicated by the differences in microstructure, which could be a major factor in thermal-mechanical fatigue. Both rafting of the γ' -phase and the absence of its fine spherical particles near the major fractures are indications of overheating. Overheating was also indicated by the microstructural features of the vane material as shown below.

Fig. 6. An example illustrating variations in the structure of γ' -phase within the airfoil of the blade material. (a) Bright-field STEM image at a distance about halfway from the major fractures of Fig. 1 showing the presence of the cuboidal γ' and spherical γ' particles; the inset is a microdiffraction pattern derived from a γ' particle in $(001)_{\text{fcc}}$ orientation. (b) Bright field STEM image showing a considerable rafting of the γ' -phase and absence of the spherical γ' particles typical of regions near the major fracture surfaces.

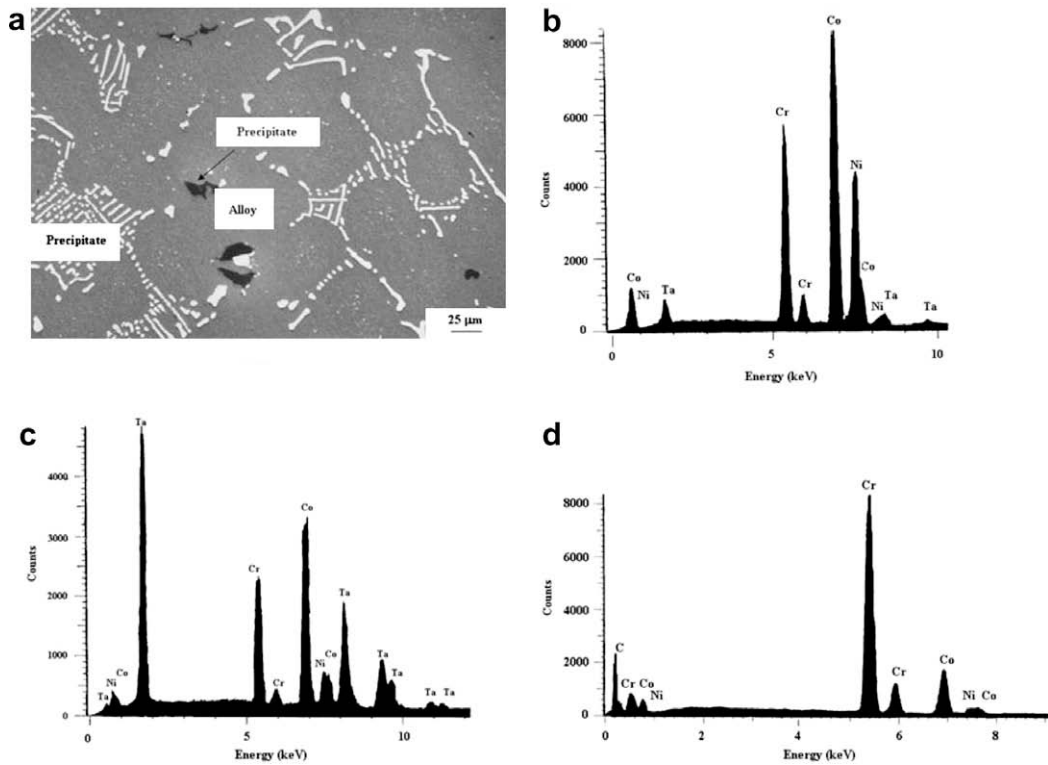
Fig. 7 summarizes typical microstructural features of the vane material in the as-received condition. As shown in the backscattered electron image of Fig. 7a, the grain boundaries were delineated by a continuous network of precipitates assuming a cellular-type morphology (bright contrast). Some discrete particles are also observed within the matrix phase attached to particles exhibiting darker contrast as indicated by the arrow. An example illustrating the elemental composition of the alloy is shown in the energy dispersive X-ray spectrum of Fig. 7b. Quantification of the spectral data showed that the composition is consistent with that of alloy MAR M 918 as specified.

Although the morphology of the grain boundary precipitates observed in Fig. 7a resembles the script-type morphology exhibited by MC-type carbides, detailed analysis showed that although some Ta-rich MC carbide was present, most of the precipitates consisted of Laves phase and $M_{23}C_6$ carbide to a lesser extent. An energy dispersive X-ray spectrum representative of the major portion of the grain boundary precipitates is shown in Fig. 7c. As can be seen, the major elemental con-

Fig. 7. Characteristic microstructural features of the vane material in the as-received condition. (a) Backscattered electron image illustrating a network of cellular precipitates at grain boundaries and scattered discrete particles within the matrix phase. (b) An energy dispersive X-ray spectrum illustrating the elemental composition of the grain boundary precipitates. (c) An energy dispersive X-ray spectrum illustrating the elemental composition of the vane material. (d) An energy dispersive X-ray spectrum illustrating the elemental composition of the matrix precipitate indicated by the arrow in (a).

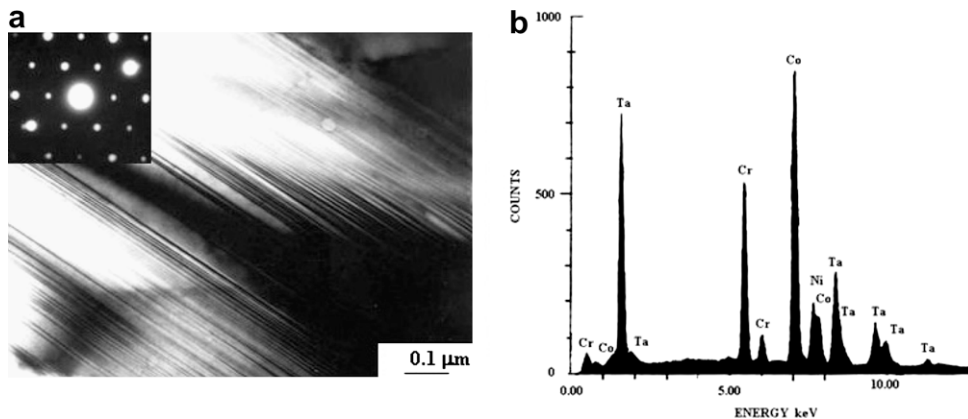
Fig. 8 is an example illustrating the results of STEM analysis of the grain boundary precipitates observed in Fig. 7a. As shown in the bright-field image of the Fig. 8a, the precipitate contained a high density of planar defects (twins and stacking

faults) characteristic of topologically close-packed phases. The inset of Fig. 8a shows a corresponding electron diffraction pattern in $[0001]_{\text{hcp}}$. An energy dispersive X-ray spectrum derived from the precipitate in the STEM mode using a windowless detector is shown in Fig. 8b, which is similar to that of Fig. 7c. These results provide evidence that similar to the case of the blade described earlier, the vane was also exposed to higher than normal temperatures. Although carbides of the MC-type (Ta-rich in the present case) provide a major source for strengthening Co-base alloys, they are known to decompose at elevated temperatures [10]. This could explain at least partially, the presence of the Ta-rich Laves phase and to a lesser extent the Cr-rich $M_{23}C_6$ carbide in the vane material. It is well known that Laves phase degrades the mechanical strength of both Ni- and Co-base alloys [11].

Fig. 8. An example illustrating the results of STEM analysis of Laves phase at grain boundaries of the vane material. (a) A bright-field image showing a high density of planar defects within a precipitate particle; the inset is a diffraction pattern in $[0001]_{\text{hcp}}$ orientation. (b) Corresponding energy dispersive X-ray spectrum illustrating the elemental composition of Laves phase.

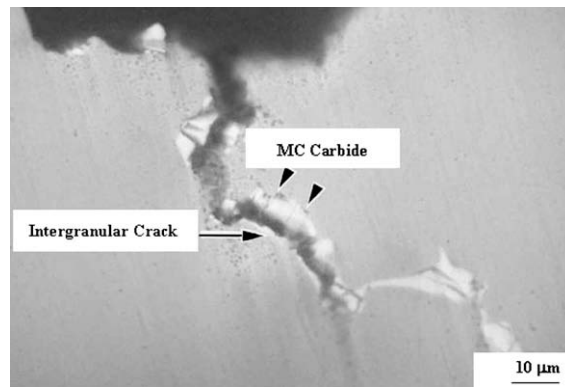
Fig. 9. Secondary electron image of a cross-section of the blade material showing an intergranular crack, and the grain boundary layer of MC carbide.

Examination of cross-sections of the fractured blade revealed the presence of secondary intergranular cracks as shown in the example of Fig. 9. This could be related to the embrittling effect of the network of grain boundary carbides degrading the creep strength. Fig. 10 summarizes some morphological features of the fracture surface revealed after descaling. In some regions of the surface, fracture appeared to occur by an intergranular mode as shown in Fig. 10a consistent with the result of

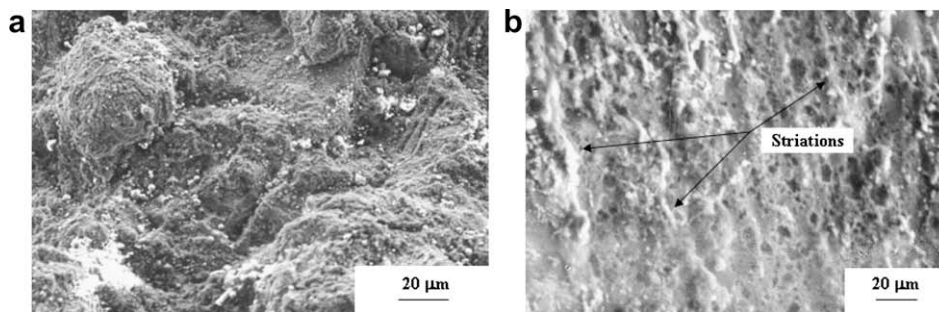
Fig. 10. Secondary electron images illustrating the fracture surface of the blade material after descaling. (a) A region showing intergranular failure. (b) A region exhibiting striations typical of fatigue failure.

Fig. 9. However, other regions of the surface exhibited striations typifying fatigue failure as shown in Fig. 10b. Similar results were obtained in the case of the vane as summarized in Figs. 11 and 12. Secondary intergranular cracks were observed along cross-sections as shown in Fig. 11. After descaling, the fracture surface exhibited some features indicating that fracture occurred by a mixed mode consisting of intergranular failure and fatigue as shown in Fig. 12. It is possible that misfiring leading to large variations in temperature as indicated by the microstructural changes described earlier could have played an important role in thermal–mechanical fatigue.

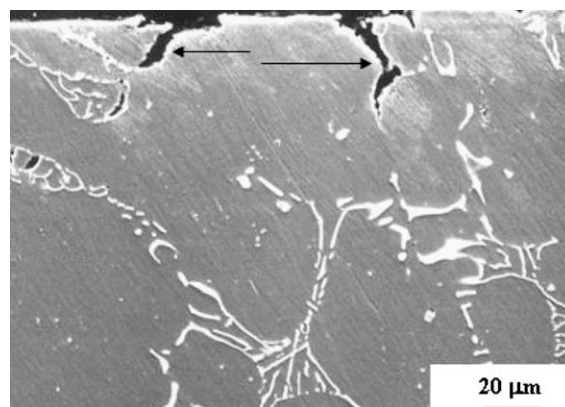
Fig. 11. Secondary electron image showing intergranular cracking along a cross-section of the vane material, as indicated by the arrows, and the network of grain boundary precipitates.

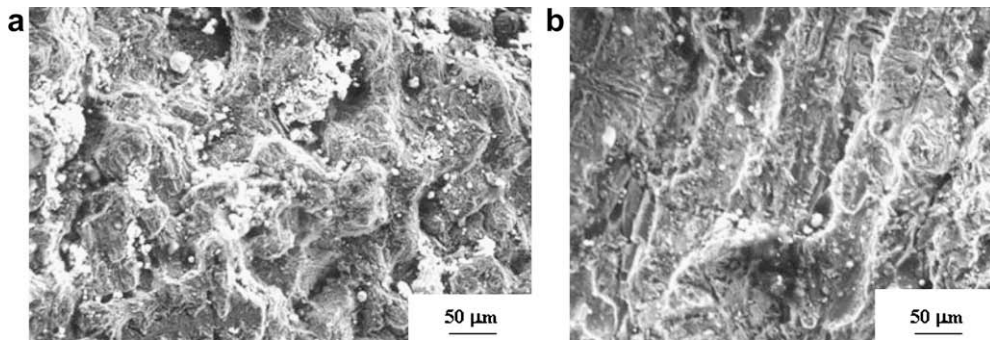
Fig. 12. Secondary electron images illustrating the fracture surface of the vane material after descaling. (a) A region exhibiting intergranular failure. (b) A region exhibiting striations typical of fatigue failure.
