Comparative performance of turbine blades used in power generation: Damage vs. microstructure and superalloy composition selected for the application

H.M. Tawancy*, Luai M. Al-Hadhrami

Center for Engineering Research, Research Institute, King Fahd University of Petroleum and Minerals, Box 1639, Dhahran 31261, Saudi Arabia

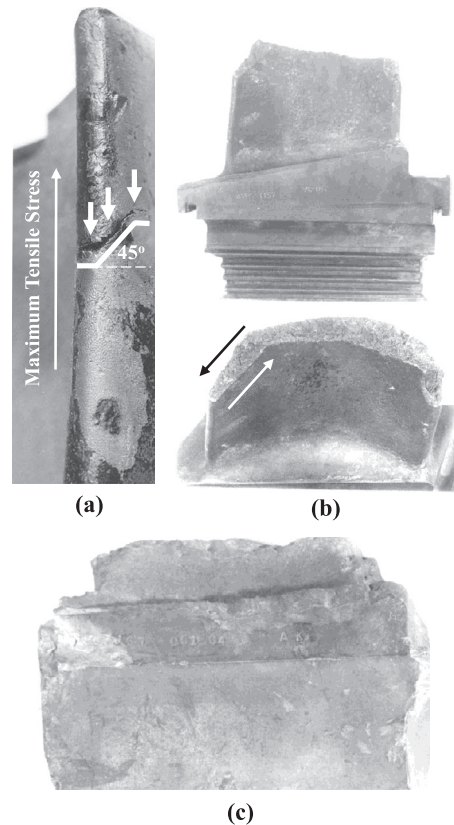
Photographs illustrating the extent of damage sustained by each blade are shown in Fig. 5. Except for a relatively thicker oxide layer on the fracture surface of the blade made of alloy 710, there has been no macroscopic evidence for corrosion attack suggesting that the damage sustained by the three blades is mostly of mechanical nature.

As illustrated in Fig. 5a and Table 2, the blade made of alloy 520 has developed an open crack at the leading edge after about 8100 h of operation. However, there has been no evidence for macroscopic deformation. It is observed from Fig. 5a that the crack has propagated along two distinct directions. At the edge of the blade, the crack has propagated along a direction oriented at about 45° to the direction of maximum tensile stress, which is typical of mode III fracture (shear or slant fracture) leading to the formation of a shear lip. Propagation is then observed to change into a direction normal to the direction of maximum tensile stress typifying mode I fracture (flat fracture). It is well known that slant fracture occurs in thin plates under plane stress condition and flat fracture occurs in thick plates under plane strain condition. Therefore, crack

Fig. 5. Photographs illustrating the general appearance of used blades. (a) Blade of alloy 520 containing an open crack. (b) Fractured blade of alloy 720. (c) Fractured blade of alloy 710.

propagation by mixed mode I/III corresponds to a plate of intermediate thickness and can be produced by a combination of tension and torsion [21,22]. Such a change in crack propagation mode can result from variation in the stress distribution at the crack tip as well as the microscopic processes responsible for the fracture [23,24].

Fig. 5b shows the blade made of alloy 720, which has completely fractured by mixed mode I/III after 74,461 h of operation. Also in this case, there has been no evidence for noticeable macroscopic deformation. Another case of complete fracture is shown in Fig. 5c for the blade made of alloy 710. In this case, complete fracture has occurred after about 1844 h of operation. However, as observed in Fig. 5c, the blade has undergone extensive macroscopic deformation, which is indicative of higher than normal temperature.

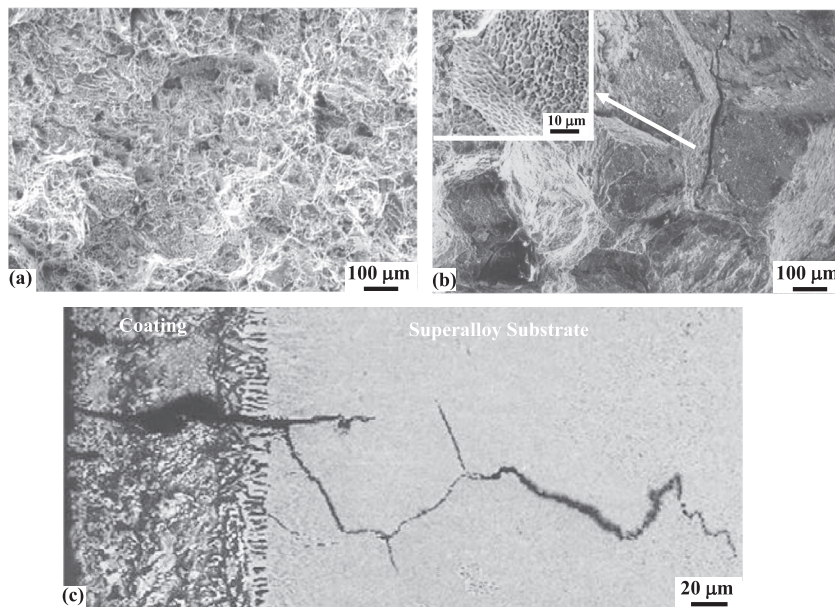
Fig. 6 shows secondary electron SEM images illustrating the characteristic morphologies of the surfaces exposed by the crack of Fig. 5a (alloy 520). Fracture by microvoid coalescence is observed in the shear lip near the edge of the blade as illustrated in Fig. 6a. Although Fig. 6b shows that fracture in the flat region has occurred by intergranular separation, microvoid coalescence is observed at separated grain facets as illustrated in the inset similar to that observed in systems containing alloy-depleted zones alongside grain boundaries [25]. However, as further discussed later, intergranular separation can be aided by precipitation of secondary phases and microvoids at grain boundaries can also result from creep deformation. In addition to the macroscopic crack observed in the blade of Fig. 5a, secondary cracks are observed along cross-sections of the coating and into the superalloy substrate as illustrated in the example of Fig. 6c. It is observed that the crack has propagated in a straight path through the Cr-modified aluminide coating and to some extent through the superalloy

Fig. 6. Secondary SEM images illustrating the morphology of surfaces exposed by the open crack in Fig. 5a and secondary cracks. (a) Fracture by microvoid coalescence in the slant section (mode III). (b) Intergranular fracture in the flat section with microvoid coalescence in separated grain facets (mode I). (c) Secondary crack along the coating and into the superalloy substrate.

substrate and then assumed a zig-zag path indicative of propagation along grain boundaries. Crack propagation in straight path of coated superalloys is known to result from thermal fatigue [26]. It is noted here that the resistance to fatigue failure is known to be reduced by creep damage [27]. Cracks such as those shown in Fig. 6c can lead to spallation of the protective coating and provide an easy path for grain boundary oxidation as shown later. Also, it is noted from Fig. 6c that in comparison with the as-deposited condition (Fig. 4a) zones I and II of the coating have become indistinguishable, which can result from significant interdiffusion.

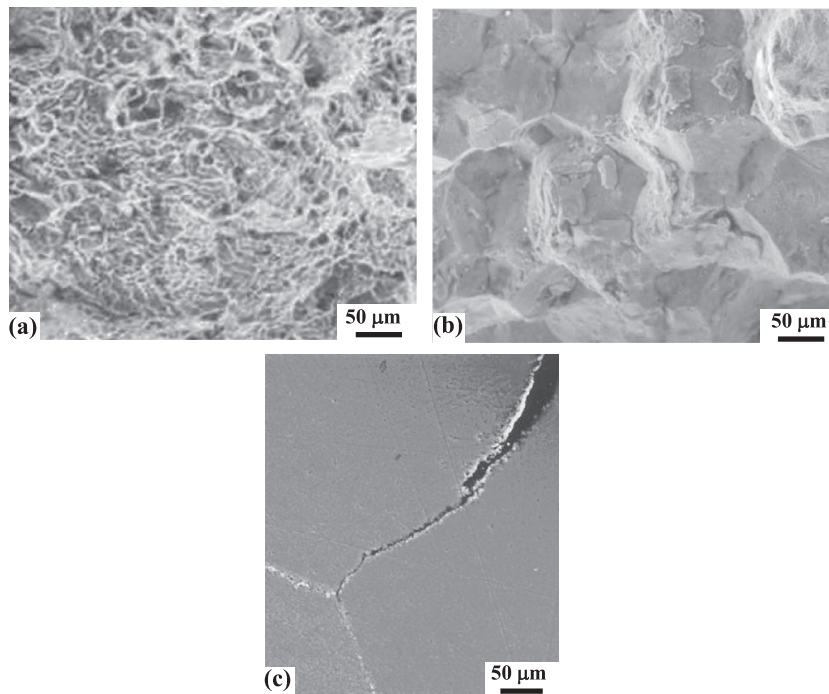
Qualitatively, the fracture behavior of the blade shown in Fig. 5b (alloy 720) is found to be similar to that of the blade shown in Fig. 5a except that there has been no evidence for visible fatigue cracks. As illustrated in the secondary electron SEM image of Fig. 7a, fracture in the shear lips has occurred by microvoid coalescence. Fig. 7b shows that fracture in the central flat region has occurred by an intergranular mechanism. Furthermore, intergranular cracks are observed along cross-sections of the blade as shown in the example of Fig. 7c. However, the respective blade lives (Table 2) indicate that crack propagation has occurred at a much slower rate in comparison with the blade made of alloy 520. Although this difference in behavior may be related to higher than normal temperature in the case of alloy 520, the characteristic composition of alloy 720 may have been a contributing factor as explained later.

Fig. 7. Secondary SEM images illustrating the morphology of surface exposed by fracture of the blade in Fig. 5b and secondary cracks. (a) Microvoid coalescence in the slant section (mode I). (b) Intergranular fracture in the flat region (mode I). (c) Secondary intergranular crack along a cross-section of the superalloy substrate.

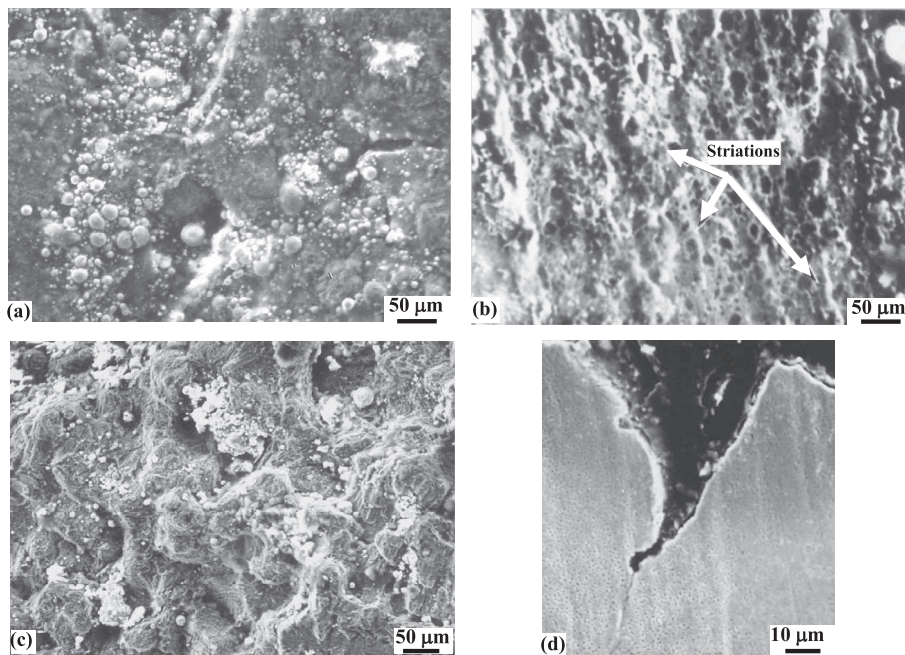
The surface exposed by fracture of the blade shown in Fig. 5c (alloy 710) is found to be rather heavily oxidized as shown in Fig. 8a. However, some important features of the fracture surface could be revealed after descaling. Striations characteristic of fatigue failure are observed near the blade edge as shown in the example of Fig. 8b. However, as shown in the image of Fig. 8c, there is an indication of intergranular separation. This is confirmed by the observation of secondary intergranular cracks along cross-sections of the blade as shown in the example of Fig. 8d. As noted earlier, higher than normal temperature results in high temperature gradient enhancing thermal fatigue.

Fig. 8. Secondary SEM images illustrating the morphology of the surface exposed by fracture of the blade in Fig. 5c and secondary cracks. (a) Surface morphology prior to descaling. (b) Striations characteristic of fatigue fracture. (c) Intergranular fracture. (d) Secondary intergranular crack along a cross-section of the superalloy substrate.

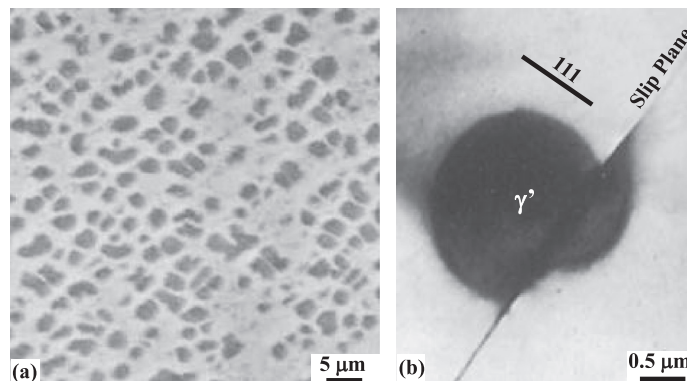
grow at the expense of smaller particles in order to reduce the surface energy of the system [28–30]. Fig. 9a shows a secondary electron SEM image illustrating the morphology of γ' -phase near the crack in the blade of Fig. 5a. It is observed that the microstructure becomes coarser in comparison with that of unused blade (Fig. 1b) leading to regions relatively free of γ' -phase and loss of the initial cubical morphology. As a result, coherency with the γ -phase is lost, which degrades the mechanical strength. Therefore, it becomes easier for dislocations to penetrate the γ' particles as shown in the bright-field TEM image of Fig. 9b.

Fig. 9. Microstructure of γ' phase in the used blade of alloy 520. (a) Secondary electron SEM image of coarsened γ' particles in the matrix γ -phase. (b) Bright-field TEM image of a sheared γ' particle.

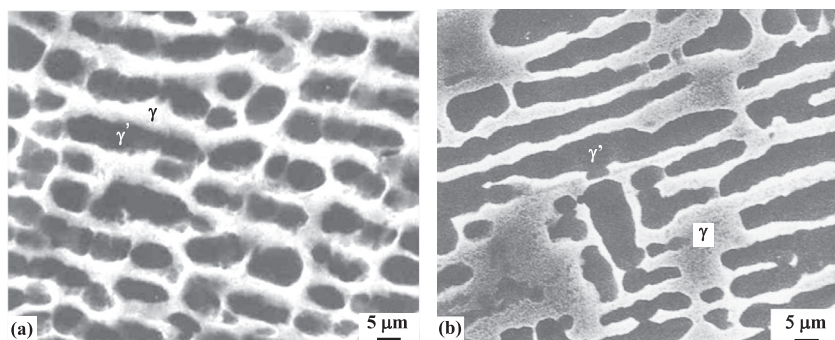
For the blades shown in Fig. 5b and c, the γ' -phase is observed to exhibit rafting morphology, which results from agglomeration and subsequent directional elongation of γ' particles under the influence of the stresses generated by the high gas pressure [4]. Examples are given in Fig. 10. Rafting is known to occur at high temperatures in excess of about 0.8 T_m (T_m is the melting point in degrees K) or with prolonged exposure at lower temperatures [4]. Therefore, it is most likely that rafting in the blade of Fig. 5b has resulted from prolonged exposure at the operating temperature. In contrast, it is more likely that higher than normal temperature is the cause of rafting in the blade of Fig. 5c. This indicates that the temperature has exceeded 1000 °C which appears to be consistent with the macroscopic deformation observed in Fig. 5c and the oxidized fracture surface of Fig. 8a.

The above observations indicate that the blade made of alloy 520 has been subjected to moderately higher than normal temperature. However, it is evident that excessively higher than normal temperature is encountered in the case of the blade made of alloy 710. In contrast, the observed life of the blade made of alloy 720 demonstrates that the design specifications have been strictly followed during service. However, as noted earlier, it is also possible that the characteristic composition of alloy 720 has been a contributing factor. It is shown later, that this may be related to its relatively lower Cr content and the presence of a small concentration of Zr as shown in Table 1.

Fig. 10. Secondary electron SEM images illustrating rafting of γ' -phase in used blades of alloys 720 (a) and 710 (b).

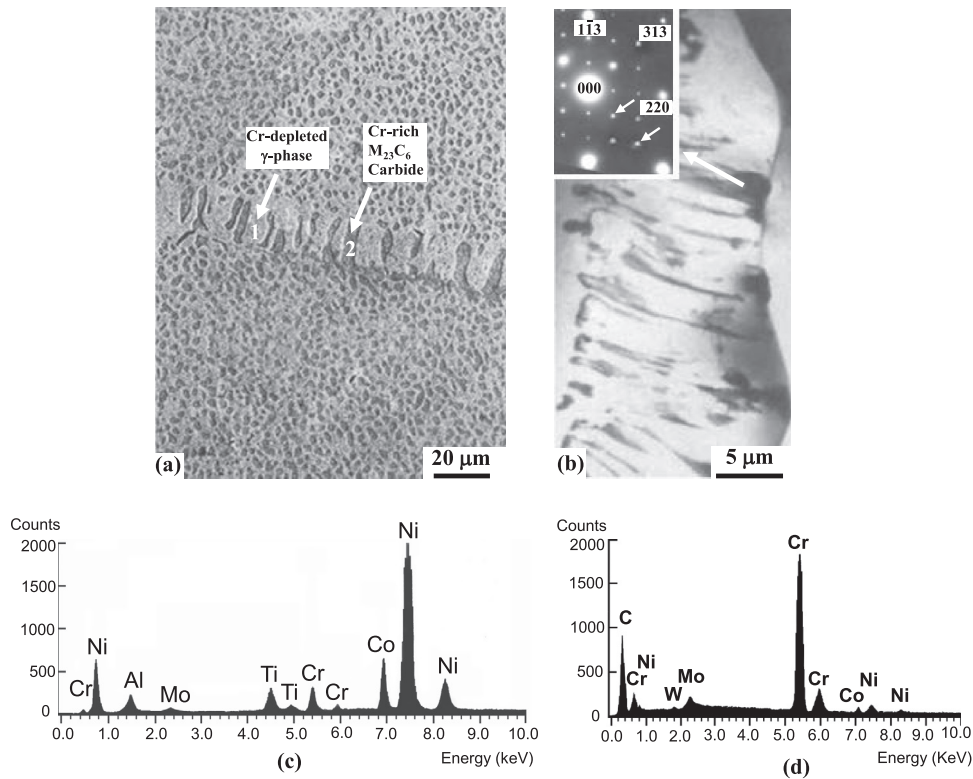
Fig. 11. Discontinuous grain boundary precipitation of Cr-rich $M_{23}C_6$ carbide in used blade of alloy 520. (a) Secondary electron SEM image illustrating lamellar carbide structure at a grain boundary. (b) Bright-field TEM image illustrating the lamellar carbide structure; the inset is a characteristic microdiffraction pattern of the carbide in $\langle \bar{3}32 \rangle_{fcc}$ orientation. (c) Energy dispersive spectrum derived from region 1 in (a). (d) Energy dispersive spectrum derived from region 2 in (a).

At relatively low temperatures where precipitation of $M_{23}C_6$ carbide is more controlled by short-circuit diffusion along grain boundaries, the reaction occurs by a discontinuous mechanism resulting in characteristic lamellar or cellular morphology [35] such as that shown in the secondary electron SEM image of Fig. 11a, which is derived from a region away from the crack in the blade of Fig. 5a. As can be seen, the lamellar structure is distinguished from the matrix phase by being free of γ' particles. Fig. 11b shows a bright-field STEM image of the lamellar grain boundary structure and corresponding microdiffraction pattern of the cubic carbide phase with fcc structure in $\langle \bar{3}32 \rangle_{fcc}$ orientation. It is typical of $M_{23}C_6$ carbide to have a lattice constant about three-times that of the γ -phase and therefore, it produces characteristic reflections at every one-third position of the γ -phase reflections [36] as observed in Fig. 11b. The energy dispersive spectra of Fig. 11c and d illustrate the elemental compositions of the regions marked 1 and 2 in Fig. 11a respectively. As can be seen, the elemental composition of region 1 is consistent with that of γ -phase, and the composition of region 2 is consistent with that of the carbide phase. Also, it is observed that the lamellar grain boundary structure is free of γ' particles and that the lamellar regions of γ -phase are depleted in Cr. It is well known that a lamellar structure such as that shown in Fig. 11a is detrimental to creep-rupture life and ductility [31–35,37]. Furthermore, the Cr-depleted regions become susceptible to high oxidation rate.

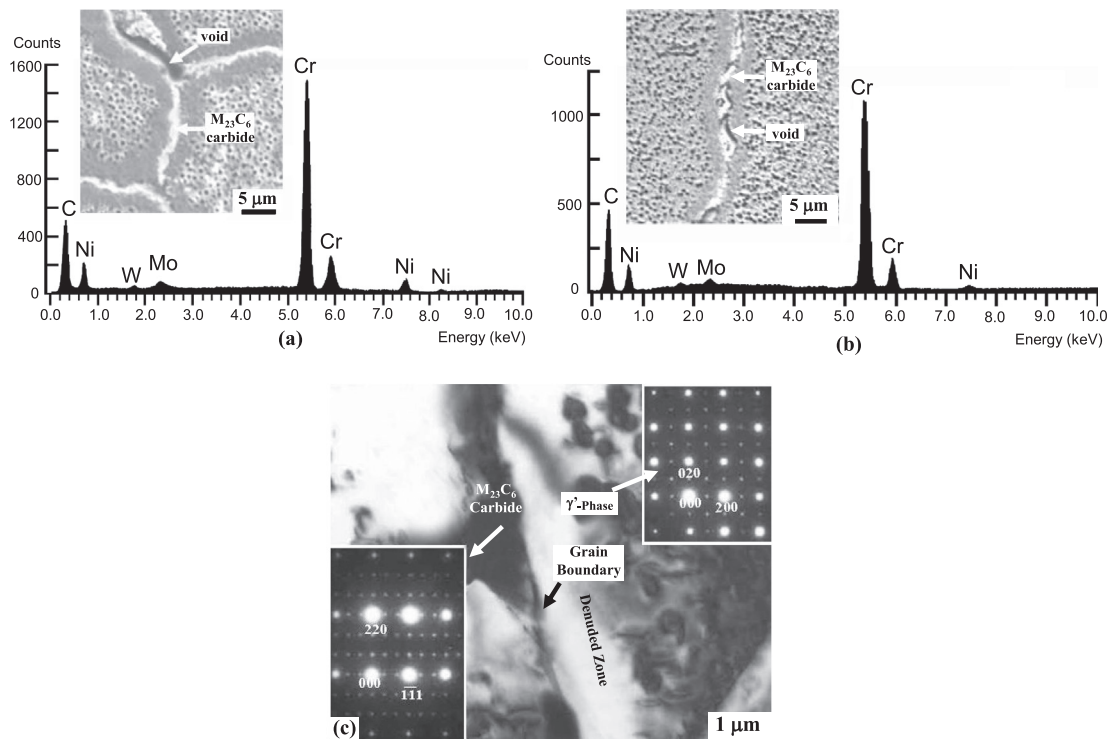
For the blades shown in Fig. 5b and c, the $M_{23}C_6$ carbide is observed to have the morphology of a continuous grain boundary layer as shown in the backscattered SEM images of Fig. 12a and b and corresponding energy dispersive spectra. This observation indicates that the reaction has been more controlled by volume diffusion and therefore, it has occurred at a relatively higher temperature in comparison with the case shown in Fig. 11. Voids within the carbide precipitate at the grain boundaries can also be observed from Fig. 12a and b. Fig. 12c is an example derived from the blade of Fig. 5c to illustrate the γ' -denuded zone as viewed on the finer scale of TEM. The $M_{23}C_6$ carbide at the grain boundary and γ' -phase in the matrix are indicated by their characteristic microdiffraction patterns in $\langle 112 \rangle_{fcc}$ and $\langle 001 \rangle_{fcc}$ orientations respectively. Similar to the case of lamellar structure described above (Fig. 11), γ' -denuded zones such as those shown in Fig. 12 can have detrimental effects on mechanical strength [37].

Fig. 12. Formation of γ' -denuded zones alongside grain boundaries containing continuous layers of $M_{23}C_6$ carbide in used blades made of alloys 720 and 710; grain boundary voids are indicated by the arrows. (a) Secondary electron SEM image and corresponding energy dispersive spectrum derived from the carbide phase in the blade made of alloy 720. (b) Secondary electron SEM image and corresponding elemental composition derived from the carbide phase in the blade made of alloy 710. (c) An example derived from the used blade 710 to illustrate the γ' -denuded zone as observed on the scale of TEM (bright-field TEM image and corresponding microdiffraction patterns of the $M_{23}C_6$ carbide and γ' -phase in $\langle 112 \rangle_{fcc}$ and $\langle 001 \rangle_{fcc}$ orientations respectively).

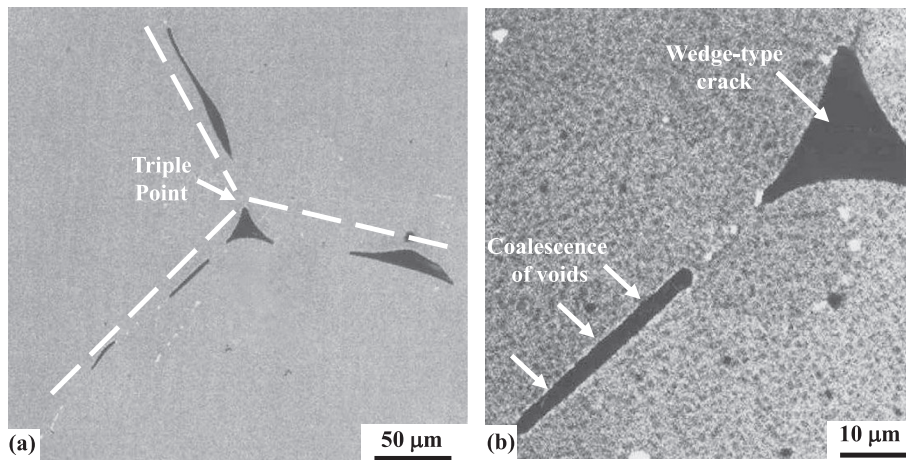
All three blades are found to sustain creep damage as reflected by the characteristic grain boundary cracks and cavitation. Fig. 13 shows an example derived from the blade of Fig. 5a. The secondary electron SEM image of Fig. 13a shows two modes for initiating intergranular creep failure: (i) wedge crack at a triple point, and (ii) cavities along the boundaries, which can form by coalescence of small voids. Fig. 13b shows the same region as viewed at higher magnification. Various studies have shown that grain boundary sliding plays an important role in forming the wedge cracks [40–44]. Also, some studies have shown that there is a link between the wedge cracks and cavities [40,42,43]. According to these studies, the wedge cracks result from accelerated linking of growing cavities by grain boundary sliding in the triple point region of stress concentration. Also, it has been shown that intergranular creep fracture can occur by coalescence of closely-spaced voids on grain boundaries oriented normal to the applied stress [40], which corresponds to mode I fracture. In this case, voids are observed at separated grain facets of the fracture surface [43] similar to that shown in Fig. 6b. This mode of creep fracture typically occurs at temperatures below about $0.75 T_m$ [44]. It has also been suggested that grain boundary precipitates including carbides and intermetallic phases can act as preferred sites for nucleation of voids [14,15,40] as demonstrated in Fig. 12a and b for the case of $M_{23}C_6$ carbide. Moreover, highly localized deformation in the soft γ' -denuded zones alongside grain boundaries can lead to formation of voids at the grain boundaries [37,40].

Fig. 13. Backscattered electron SEM images illustrating creep damage in used blade made of alloy 520. (a) Wedge crack at a triple point and cavities at grain boundaries. (b) Same region as viewed at higher magnification.

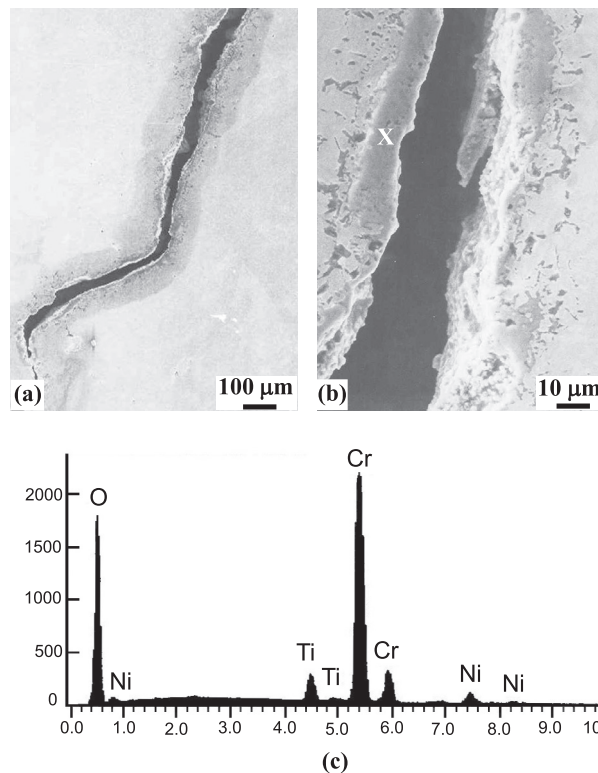
Fig. 14 shows an example derived from the blade of Fig. 5c to illustrate grain boundary oxidation induced by cracks produced by creep deformation. The secondary electron SEM images of Fig. 14a and b shows the respective oxide morphology as viewed at different magnifications. Fig. 14c is an energy dispersive spectrum derived from the region marked (x) in Fig. 14b. It is evident that the elemental composition of the oxide is consistent with that of Cr_2O_3 . This type of internal oxidation is commonly referred to as stress-assisted intergranular oxidation [45].

Fig. 14. Intergranular oxidation alongside cracks produced by fatigue/creep in used blade of alloy 710. (a) Low-magnification secondary electron SEM image illustrating the oxide layer alongside the crack. (b) Higher magnification image showing the oxide morphology. (c) Energy dispersive spectrum illustrating the elemental composition of the oxide.

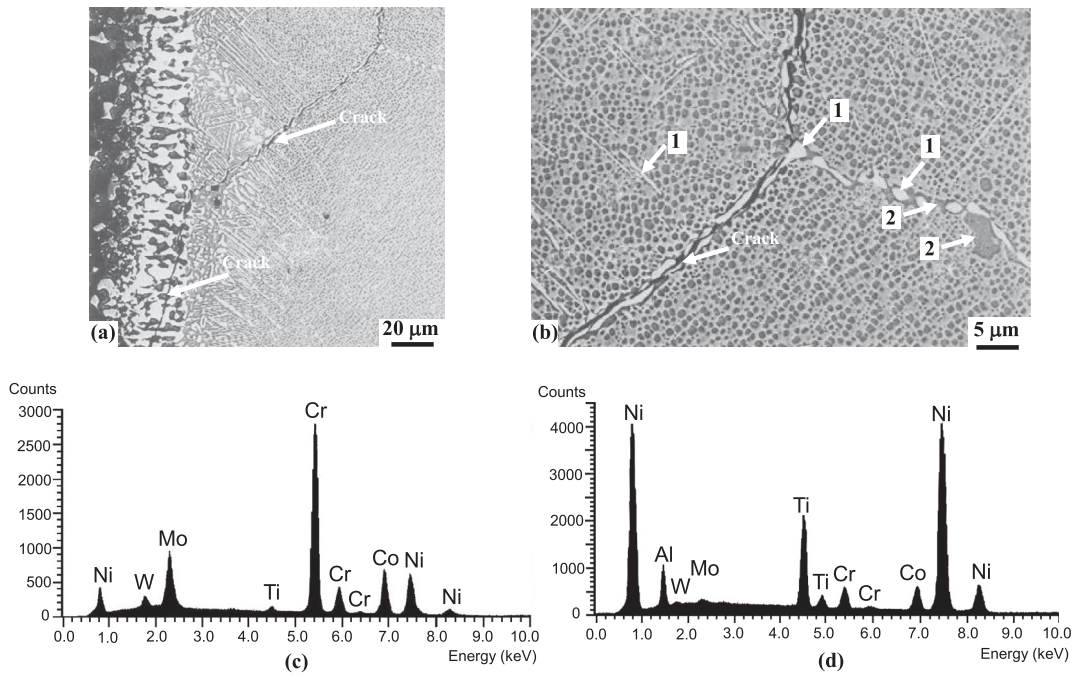
Fig. 15. Precipitation of intermetallic compounds in used blade made of alloy 520. (a) Low-magnification backscattered image showing continuous layers of grain boundary precipitates and matrix precipitates with platelet-type morphology. (b) High magnification image showing two phases at the grain boundaries. (c) Energy dispersive spectrum illustrating the elemental composition of the precipitates marked 1 at the grain boundaries and matrix phase in (b). (d) Energy dispersive spectrum illustrating the elemental composition of the grain boundary precipitates marked 2 in (b).

Precipitates of both the σ - and η -phases have been identified in the blade made of alloy 520 as summarized in Fig. 15. Backscattered electron images illustrating intermetallic precipitates at grain boundaries and in the matrix phase are shown in Fig. 15a and b. Also, a continuous grain boundary crack is observed to extend through the coating. Corresponding energy dispersive spectra illustrating the elemental compositions of the precipitates are shown in Fig. 15c and d suggesting the presence of both σ -phase of the type $(\text{Ni} + \text{Co})\text{-Cr}-(\text{Mo} + \text{W})$ and η -phase based upon the Ni_3Ti composition.

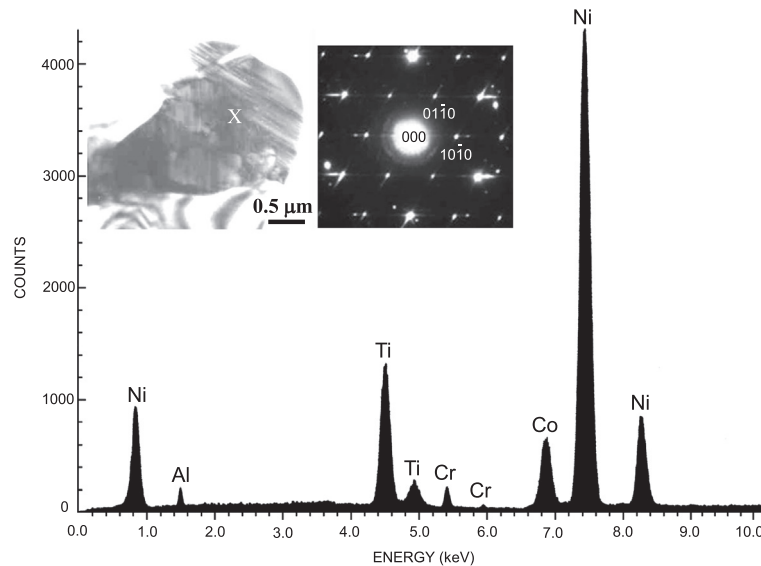
Fig. 16. Bright-field STEM image, corresponding microdiffraction pattern in $[0001]_{\text{hcp}}$, and energy dispersive spectrum illustrating a precipitate particle of η -phase (Ni_3Ti) in the blade made of alloy 720.

Also, η -phase has been identified by TEM/STEM analysis in the blade made of alloy 720 as shown in the example of Fig. 16. An η -phase particle suspended from the edge of a thin-foil is shown in the bright-field TEM image. The corresponding microdiffraction diffraction pattern in $[0001]_{\text{hcp}}$ orientation is consistent with the hexagonal DO_{24} -type structure of η -phase ($a = b = 0.25 \text{ nm}$, $c = 0.83 \text{ nm}$). Also, the corresponding energy dispersive shows that the elemental composition is consistent with that of Ni_3Ti . Fine striations observed in the Ni_3Ti particle are interpreted as stacking faults and fine twins. Evidently, precipitation of η -phase in the blade made of alloy 720 has occurred with sluggish kinetics.

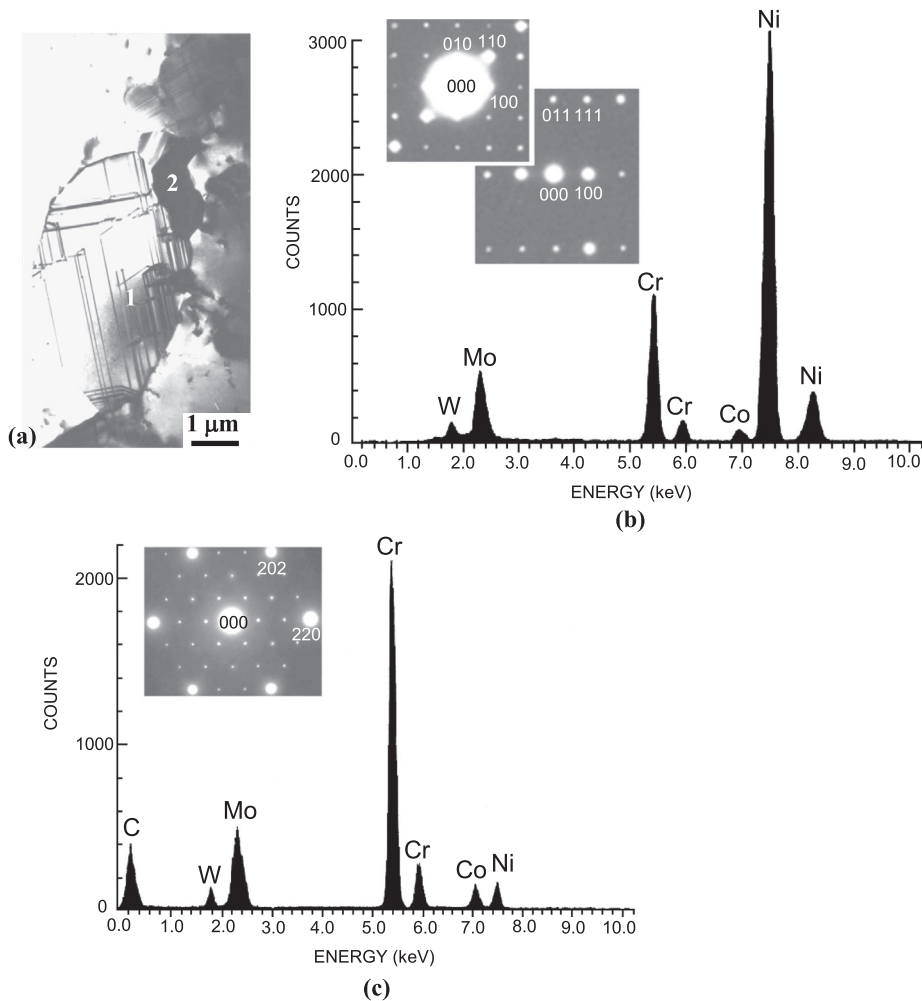
Fig. 17. Precipitation of σ -phase in the blade made of alloy 710. (a) Bright-field TEM image of grain boundary precipitates. (b) Microdiffraction patterns and energy dispersive spectrum derived from the particle marked 1 in (a). (c) Microdiffraction pattern and energy dispersive spectrum derived from the particle marked 2 in (a).

An example illustrating a mixture of M_{23}C_6 carbide and σ -phase at a grain boundary in the blade made of alloy 710 is shown in the bright-field TEM image of Fig. 17a. Fig. 17b shows two microdiffraction patterns derived from the particle of σ -phase in $[001]$ and $[0\bar{1}1]$ tetragonal orientations and corresponding energy dispersive spectrum illustrating its elemental composition. Fig. 17c shows a microdiffraction pattern in $\langle 111 \rangle_{\text{fcc}}$ orientation and corresponding energy dispersive spectrum consist with those of M_{23}C_6 carbide. It is known that pre-precipitation of the Cr-rich M_{23}C_6 carbide can act as a nucleus for precipitation of the Cr-rich sigma phase [47], which can explain the link between the two particles observed in Fig. 17a.
