Summary Pickup Truck PIV Measurements

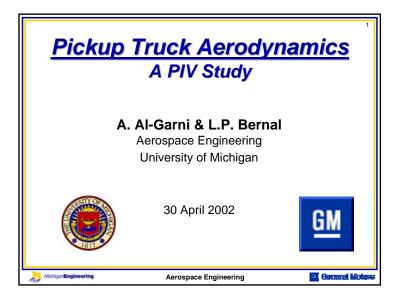
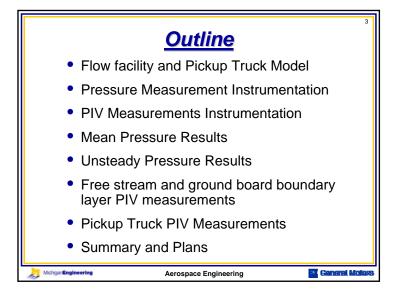
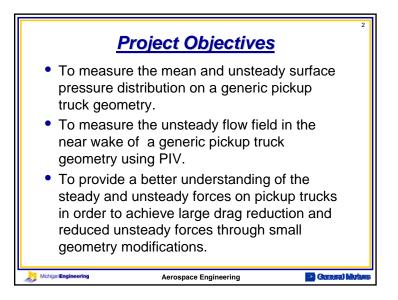
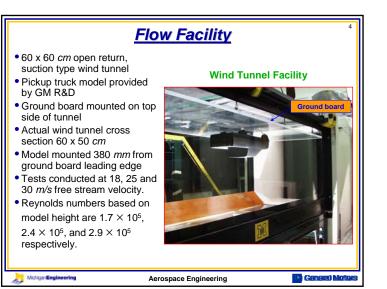
Image Processing			
 New image shift cross correlation technique has been developed. 	First Image	Second Image	
 First image shown on the left, shifted second image shown on the right. Cross correlation shown in bottom contour plot. 	10 20 30 10 20 30	10 20 30 10 20 30	
 Interrogation window was optimized for each flow condition. 	100 150 200 250 100 150 200 250 Cross Correlation Contour Plot		
• Typical search window (shown in green on the cross correlation plot.	10		
 Location of the maximum gives the particle displacement. 	0		
 Data validation tests: Maximum cross correlation inside search window. 	-10	0, 10	
 Maximum greater than threshold value dynamically determined based on noise level. 	0	500 1000
