# **SPATIAL ANALYSIS AND GUIDELINES FOR THE IMPROVEMENT OF OUTDOOR AREAS IN THE K.F.U.P.M. ACADEMIC COMPLEX**

**A Report by the Task Force Formed by  
The Campus Planning & Development Committee**

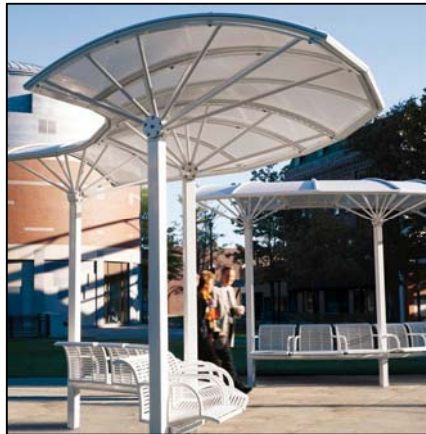
*Figure 3. Example of light weight steel seating unit for bus stand*

- ▶ Light weight steel seating should be installed at locations for bus commuters to wait in. An example of such seating is shown in figure 3
- Better quality of globe type lamp posts need to be installed in an organized manner providing an even outdoor lighting and are consistent with the name plates all over the campus

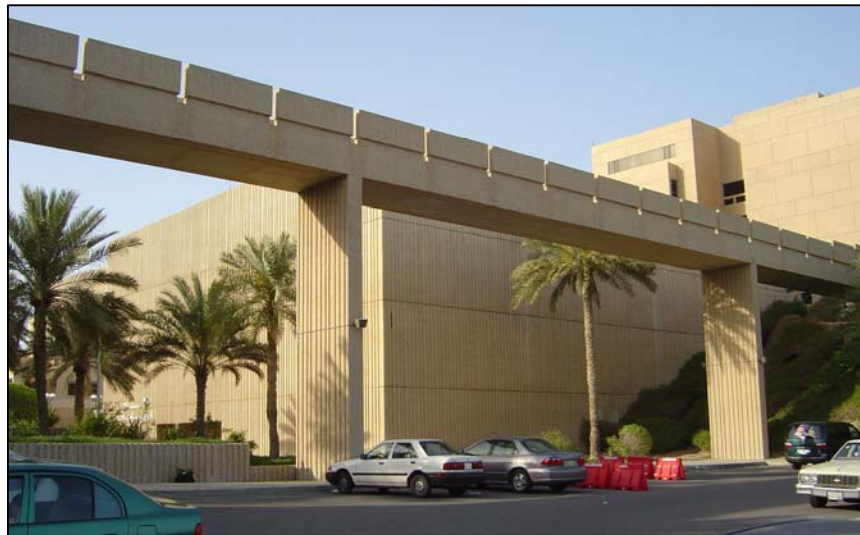
- **Pick-up Point:** Although shuttle busses commute through this area, there is no shelter for sheltering commuters.
- **Missing Entrance:** A large scale horizontal element i.e. the foot bridge acts as an entrance gateway to the academic complex nevertheless; this feature lacks the sense of identity. Its function is not unclear to a visitor nor can it be perceived as an entrance portal.

*Figure 4. The foot bridge, a meaning less horizontal member*

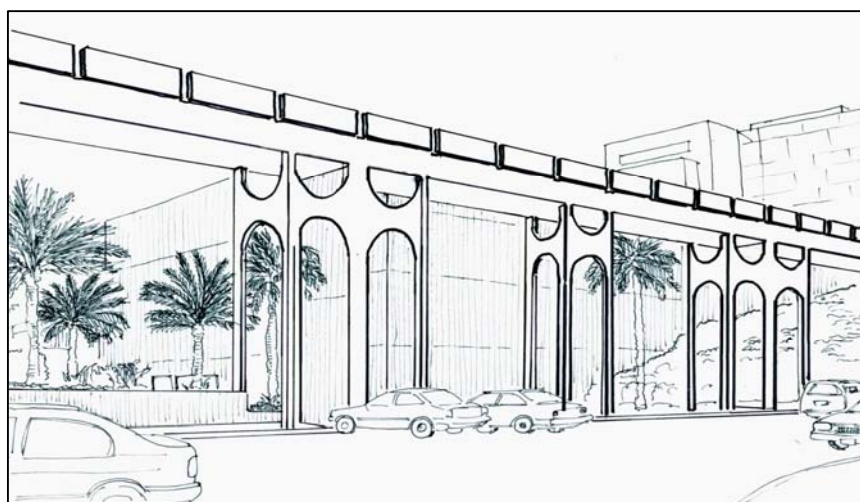
*Figure 5. The foot bridge could be converted into a gateway*

- The foot bridge that connects the left wing at building 19 to the right wing of the complex at building 21 needs to be formulated into an imposing element of the KFUPM outdoors. This walkway which is visualized as a long horizontal member, could be treated as an entrance gateway to the complex by reinforcing its vertical columns with 'arch blocks' similar to the ones that exist in the central mosque as compared in figure 4 and 5. Figure 4 shows the existing elevated walkway while figure 5 displays a conceptual sketch highlighting the additional

elements that would convert this walkway into an entrance gateway to the academic complex. Installation of these elements would also eliminate the structural problems that presently persist with the stability of this horizontal structure, at the same time; these arched elements would visually and spatially transform this element into a grand entrance to the complex

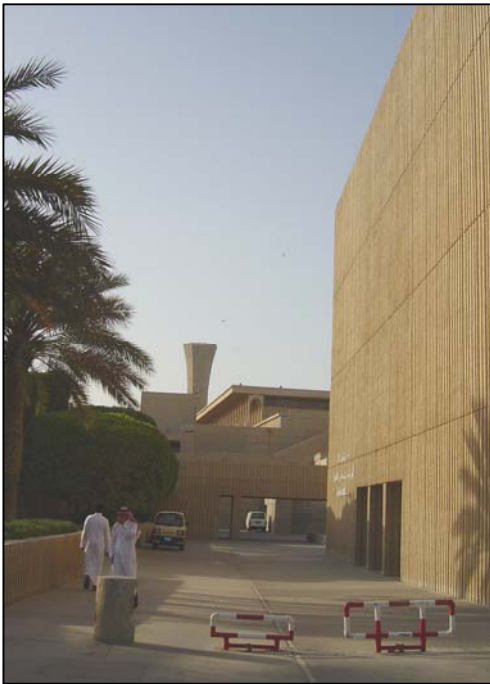
- **Auditorium Entrance:** An out of scale concrete mass acts as a welcoming building block i.e. the auditorium (building 10) whose function is uncertain as this building lack focus. The main entrance of this major facility is small in comparison to the scale of the façade and is not highlighted at all which makes its presence go unnoticed.

*Figure 6. The entrance to building 10, an out of scale façade.*

- ▶ The openings leading to the auditorium are too meager compared to the façade mass and needs to be more emphasized. One method of doing so would be to install an artificial stained (colored) glass opening (depressed) embedded with KFUPM logo and lit by lights from behind, over the door openings as shown in figure 7. This concept increases the proportions of the entry compared to the rest of the façade

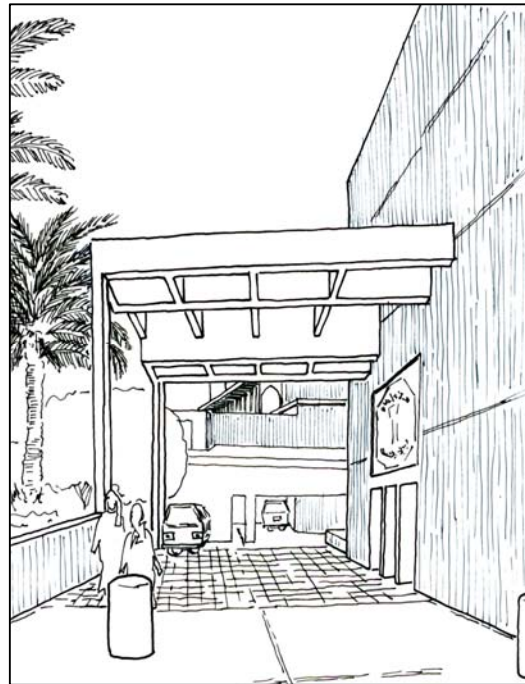
*Figure 7. Sketch showing the concept to enhance the entrance to the auditorium*

- ▶ The entrance should be further enhanced by installing a semi-open roof or pergola over the area fronting the entrance and converting the whole walkway as shown in figure 7. This would also create a transition zone between the building and its outdoors which can also be integrated with some outdoor seating

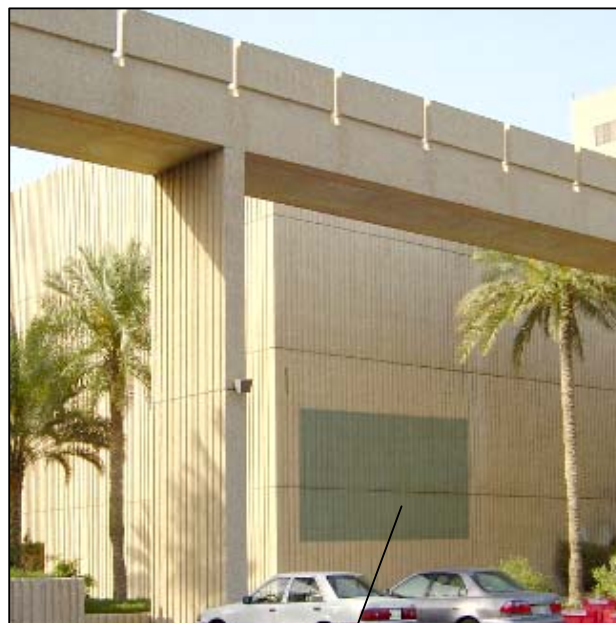
*Signage, a map of KFUPM  
academic complex*

*Figure 8. The proposed scheme and location for signage such as a KFUPM academic complex map*

- Signages and maps should be placed at key location especially in this area
  - ▶ Map boards could be installed on the blank walls of the buildings at key locations and to maintain the visibility of the finishing of the buildings, KFUPM map could be etched on clear glass with black & white color and mounted using steel bolts at the corners. Figure 8 shows an example location for this concept

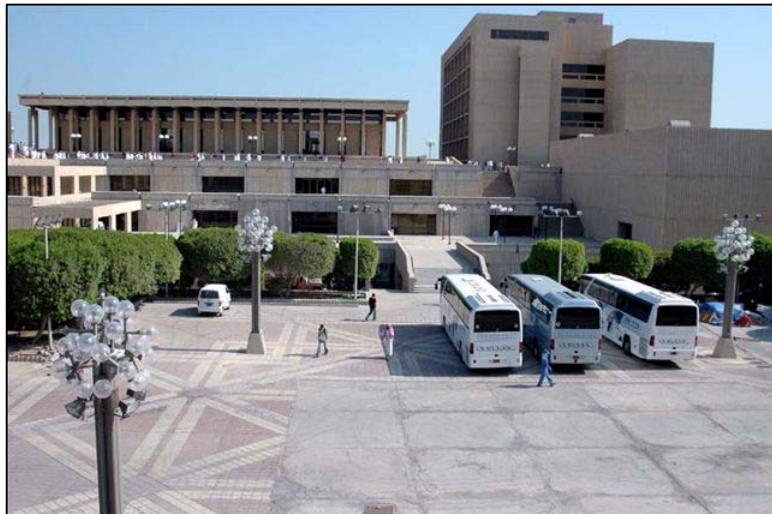
*Figure 9. The central Plaza presently used as a parking area.*

- **Central Plaza:** The central space of the plaza lacks character and its finishing and detailing makes it more of a highway for vehicles to reach various areas of the compound. The pavement is unorganized and ugly lacking any kind of direction and pattern. Such an area should have a bold focus which once again is missing. The image currently displayed surely renders this area to be conceived as a parking lot.

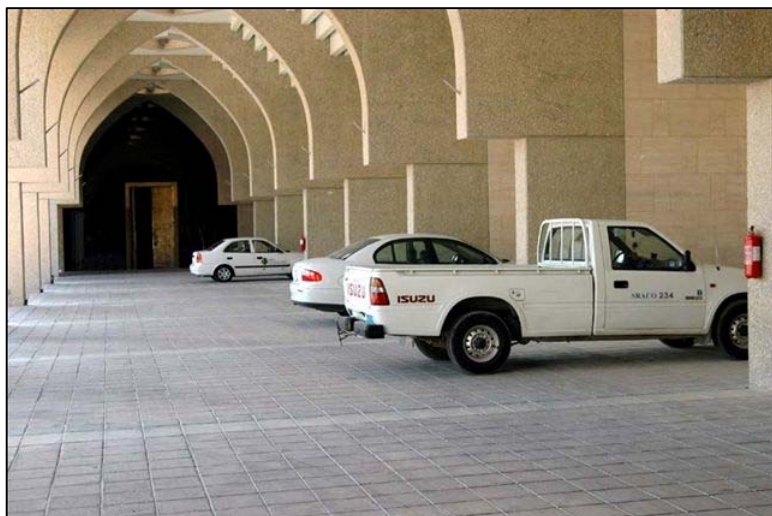
*Figure 10. The outdoor area fronting building 20 used at present as a shaded parking garage*

- **Shaded Area:** The colonnaded double height space fronting the conference hall building 20 and building 19 is an excellent breathing space for both the buildings but lacks any kind of detailing which once again makes it look like a garage or a fire station. This area is also a space of high importance but its image does not depict such functionality.

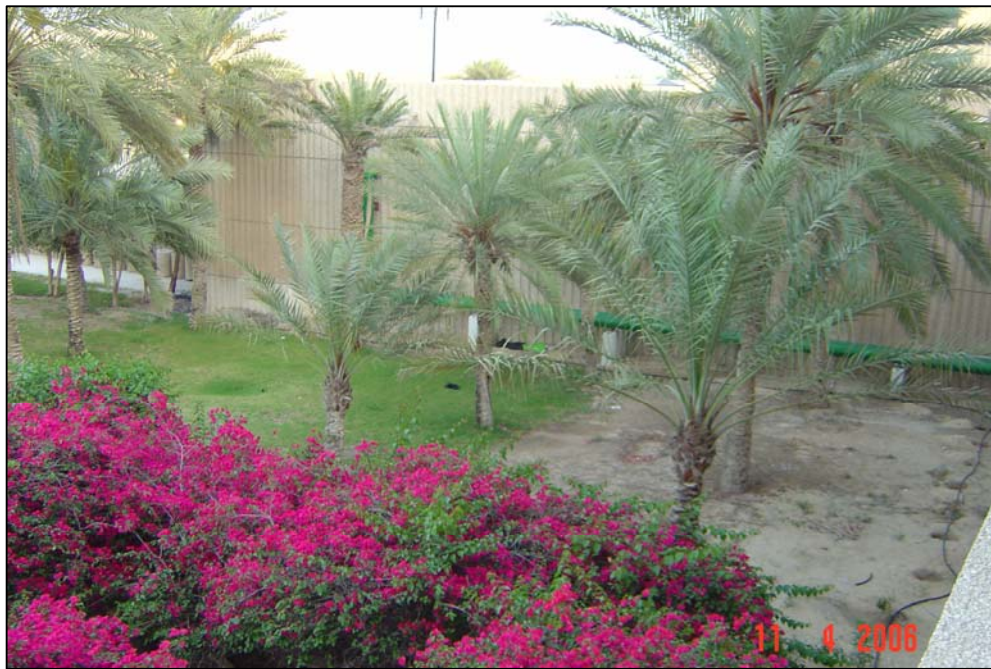
*Figure 13. The under-utilized outdoor area by the left side of the road leading to the central Mosque from the plaza could be used for a crowd pulling development.*

A hot spot for development exists on the left side of the roadway connecting the central plaza to the central Mosque. This area at the lowest level by the side of building 14 as shown in Figure 13, at present is a left out and under-utilized corner filled in with few palm trees. A light structured development that houses general functions such as a stationary, computer products, a coffee shop and out door seating integrated with the exiting palm trees similar to the conceptual sketches shown in Figure 14 would prove to be very beneficial to the KFUPM community. Such a development would act as a crowd pulling built environment which would allow users to visit, gather, and socialize in this area at the same time make them walk around the central plaza and its adjacent outdoor areas, thus allowing usage of the central spine.

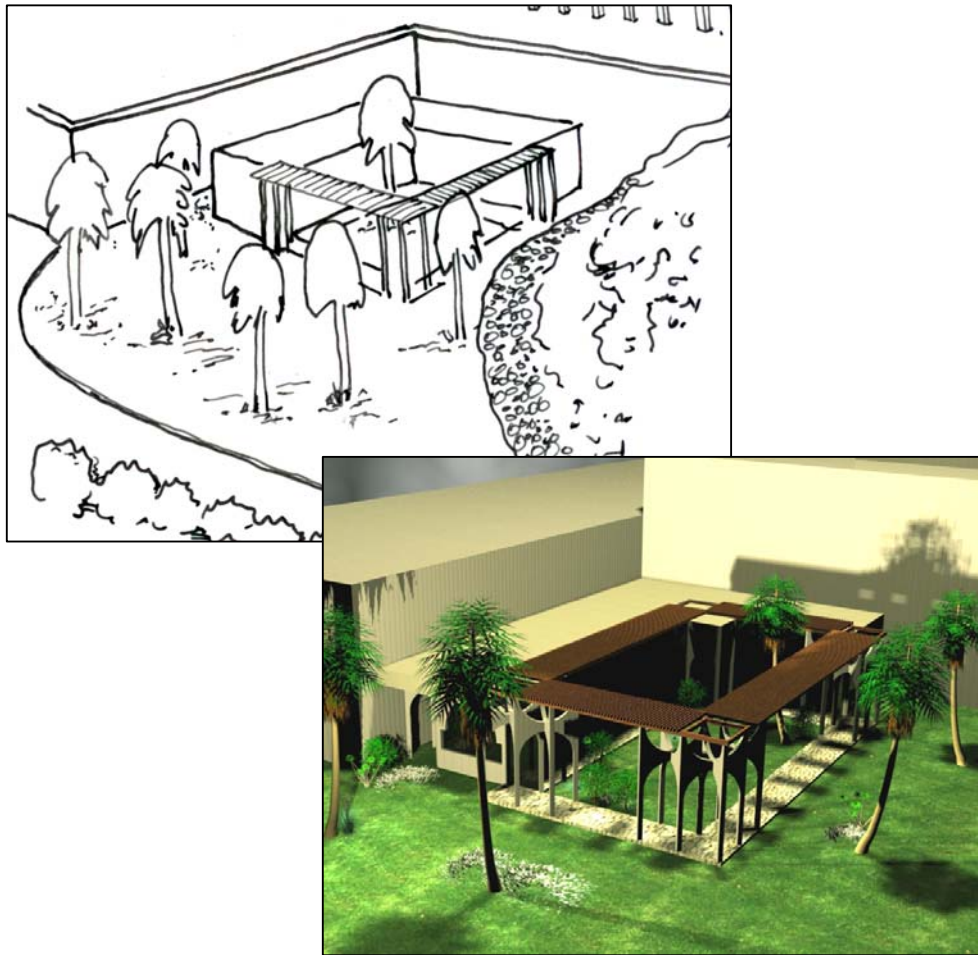
*Figure 14. The outdoor area by the side of the road way leading to the central Mosque from the Plaza could be developed with general function utilities as conceptually displayed in these sketches.*

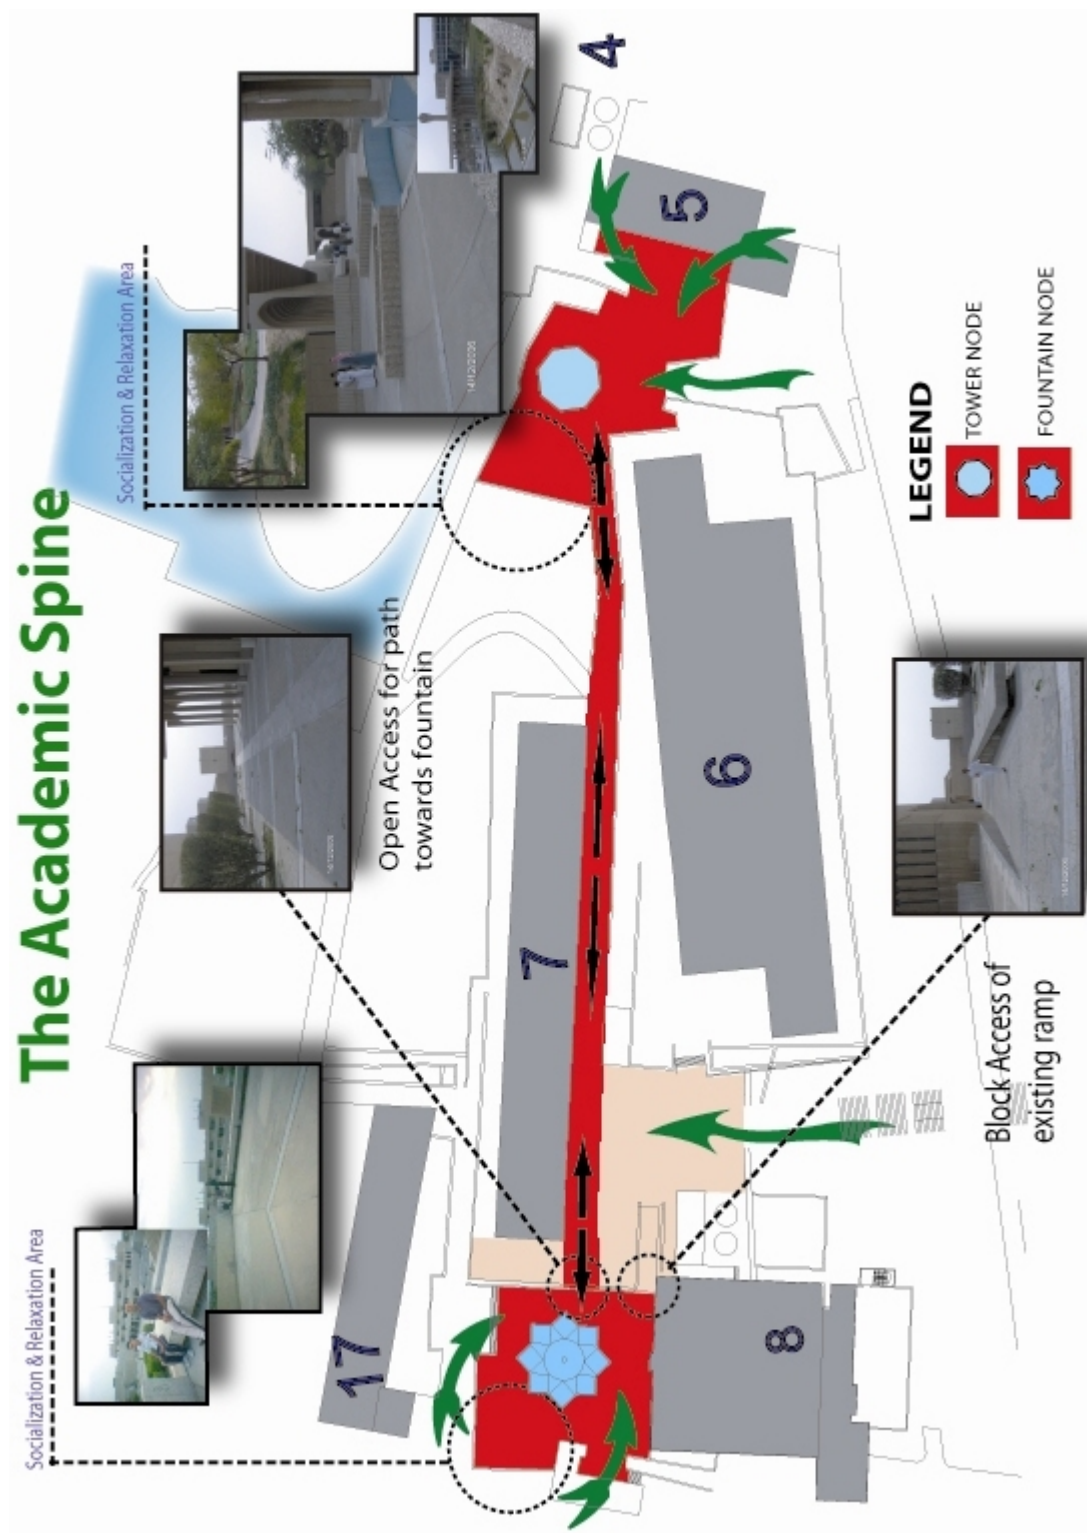
Figure 15. The outdoor areas around the academic buildings at various terrace levels that is "the Academic Spine" can be unified utilizing a single concept that enhances the visual ambience of these outdoor spaces maximizing its usage.

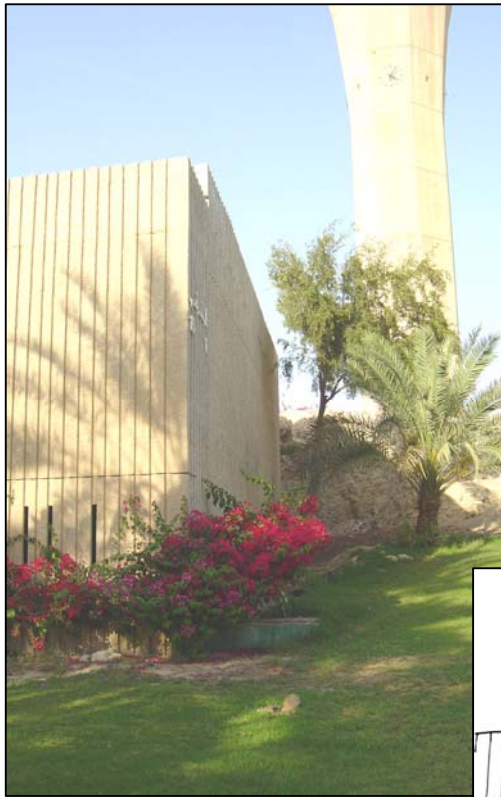
*Figure 19. The proposed location of the staircase that could connect the Tower Court with the landscaped area fronting building 16. The upper image is the existing status while the sketch at the bottom suggests the idea of the proposed staircase.*

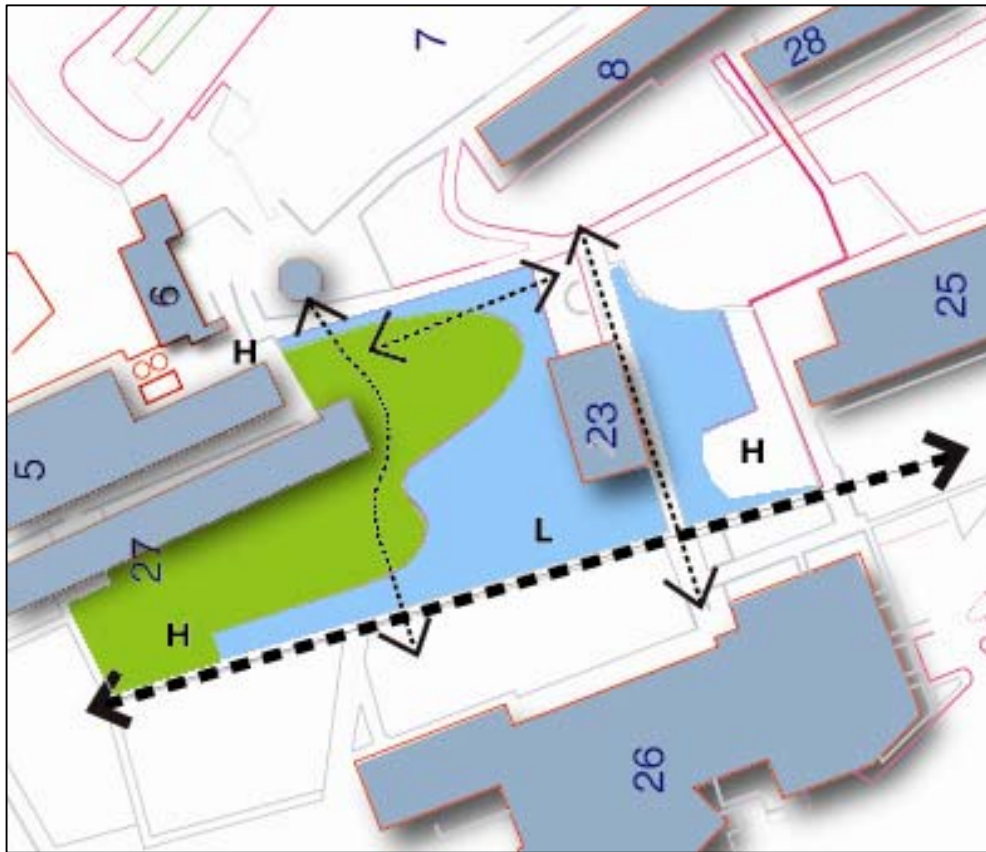
*Figure 22. The linkages around the lake need to be enhanced by incorporating additional bridges that improve functionality as shown in dashed lines. Walkway on the green side of the lake would also make the green area usable.*
