Remote sensing and GIS applications to Landslides

Term project Presentation by :

CRP 514: city and regional planning

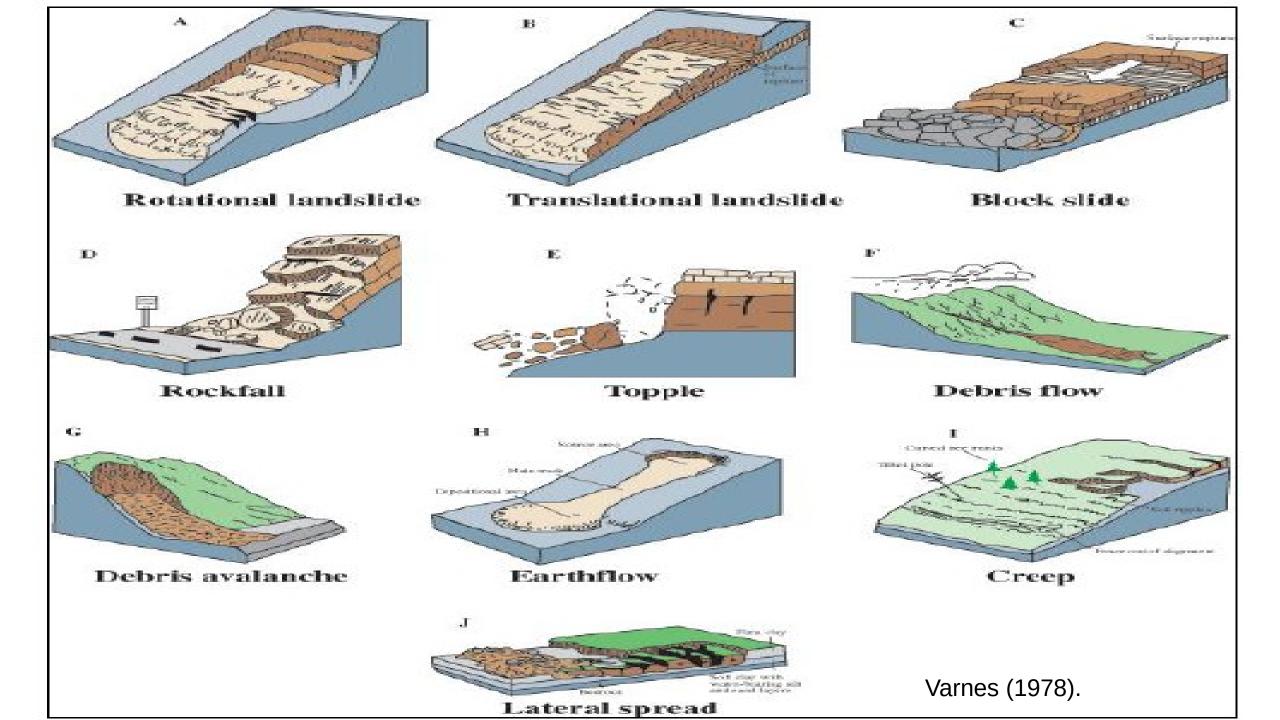
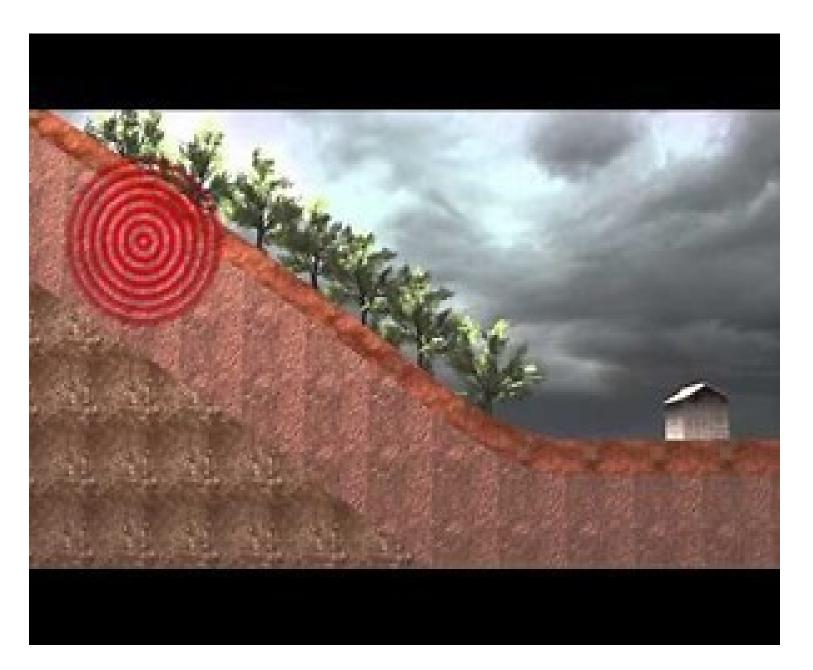
• Type of landslides:

According to Varnes (1978).

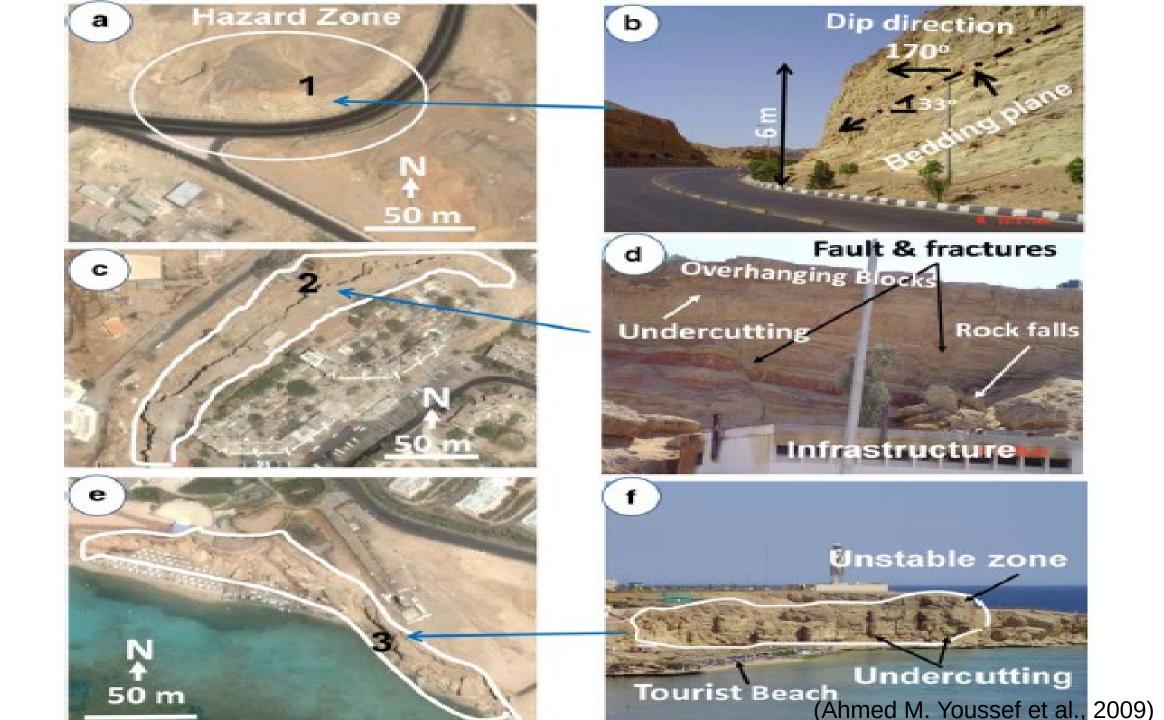
(Ahmed M. Youssef et al., 2009)

- High Spatial resolution Satelite (meter to sub-meter) have been used in this study to collected corrected image of QuickBird. The Multispectral and Panchromatic images of QuickBird have been acquired on the second of June 2007 and those images integrated with (Enhanced Thematic mapper plus (ETM+) data dated to 2001.
- The result synchronized and approved by field work.

Tension cracks

Fallen Blocks

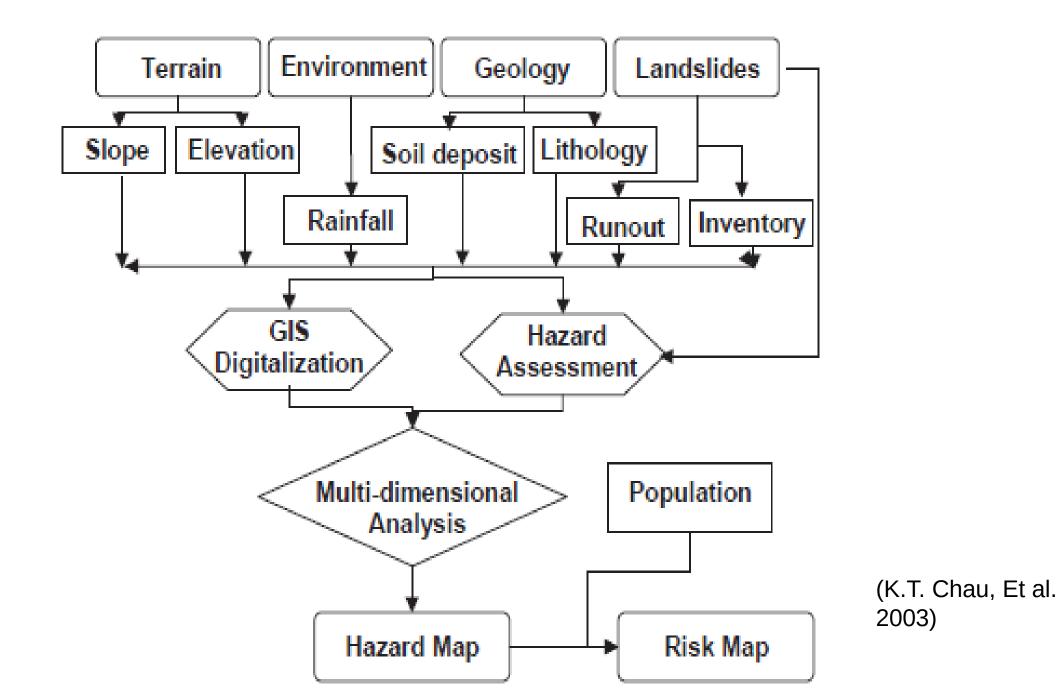
T1=elevation;

T2=slope;

E1=rainfall;

L1=potential runout

of landslides;

L2=landslide inventory

G1=soil deposition;

G2=geology.
