STRESS CORROSION CRACKING: CASE STUDIES IN REFINERY EQUIPMENT

Graham R. Lobley¹

Two examples of stress corrosion cracking (SCC) in refinery equipment are presented to highlight the lessons learned to prevent recurrence of such failures. In each failure analysis case study, the cracking is characterized using various metallurgical laboratory techniques, including metallography and fractography, in order to identify the mode of failure. Examples of polythionic acid SCC (PASCC) in a sensitized austenitic stainless steel and caustic SCC in carbon steel equipment are presented. PASCC of 304 stainless steel charge heater tubes occurred in a naphtha hydrotreater during shutdown, after about 18 years in service. Caustic SCC of carbon steel piping in an LPG Merox gas sweetening plant occurred in non-stress-relieved downstream piping, due to caustic carryover from the Merox unit. Cracking characteristics are discussed and options to avoid recurrence are presented.

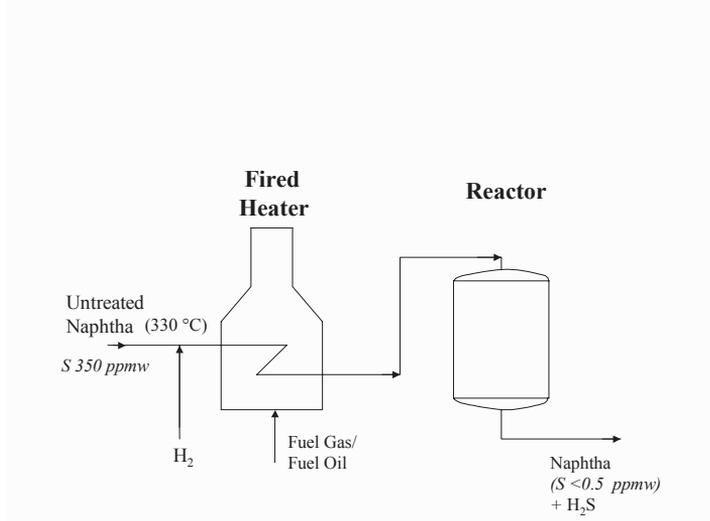
Fig. 1: simplified flow diagram of Naphtha Hydrotreater unit

The 304 stainless steel charge heater coil of a naphtha hydrotreater unit (NHT) was found to be extensively cracked following unit shutdown, when soda ash washing was applied. The NHT is fired on fuel oil/gas. The coil carries sour naphtha (350 ppmw S) feed and hydrogen is added to the feed at a process temperature of 330 °C (see simplified process flow diagram, Fig. 1). The unit had been in service for about 18 years and had been successfully shut down and restarted several times previously in its lifetime.

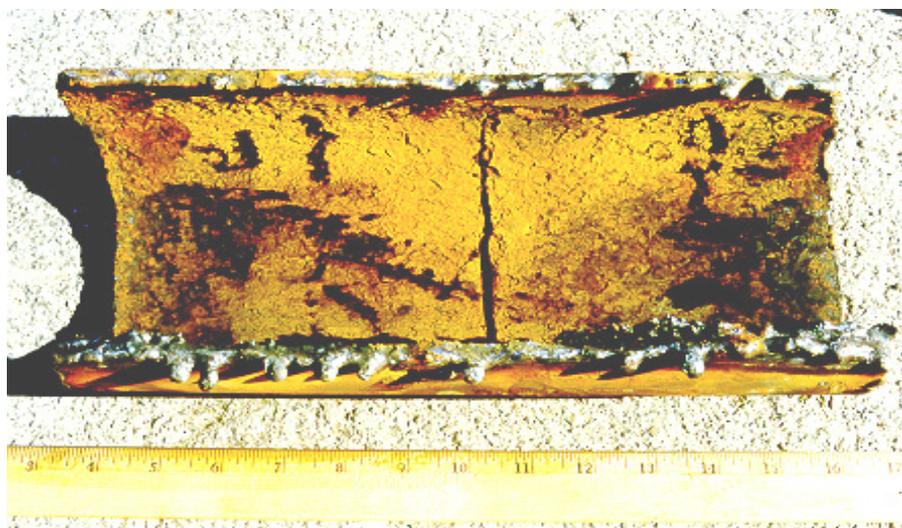
Tube sections from the heater coil were received for laboratory evaluation. These sections showed several transverse cracks, some with significant crack opening (Fig. 2). Beneath a rust flash, the internal coil surfaces were coated with a fairly thick, powdery black deposit, which was sampled for chemical analysis. Microsections taken across the cracks confirmed that the cracking had started from the internal, process side of the tube (Fig. 3). Metallography showed that cracking was intergranular with some branching (Figs. 4a, 4b). An intergranular failure was also confirmed by fractography of an opened crack (Fig. 4c). Electrolytic etching of a microsection in oxalic acid (ASTM A262 Practice A) revealed wide, ditched grain boundaries, indicative of sensitization (Fig. 4d). X-ray diffraction (XRD) revealed that the black deposit inside the tubes was 80% iron sulfide (FeS), balance iron oxide hydroxide FeOOH. The tube material met the compositional requirements of the specified ASTM A271 TP304. The alloy analysis was 18.5%Cr, 9.95%Ni, 1.55%Mn, 0.64%Si, 0.07%C.

Fig. 2: transverse cracks in heater coil

1. PASCC failure occurred in a sensitized 304 stainless steel, after 18 years' service.
2. NACE RP0170 shutdown procedures should be carefully followed for austenitic stainless steel equipment.
3. Upgrade the coil to AISI 347 stainless steel, which is significantly more resistant to sensitization. This alloy should be given a stabilization heat treatment.

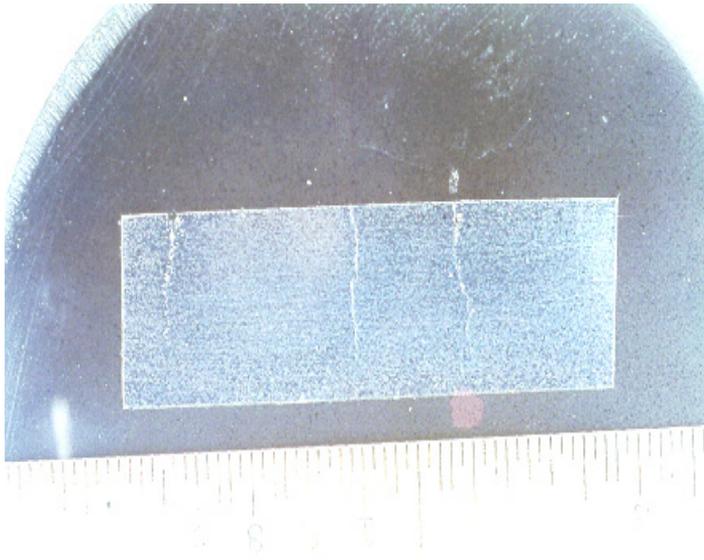
Fig. 3: cracking from ID surface (top)

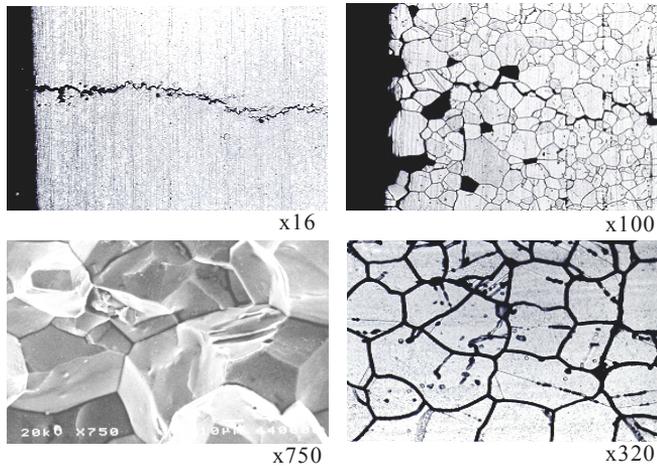
Fig. 4

Sensitization is a degraded condition in austenitic stainless steels which is caused by chromium depletion immediately adjacent to the grain boundaries. In the normally used solution annealed condition, chromium is uniformly distributed within the austenite microstructure. However, if the alloy is heated in the approximate sensitization range 370 – 815 °C (700 – 1500 °F) [NACE, 1997], chromium carbide precipitation occurs at the grain boundaries. A narrow region adjacent to the chromium-rich intergranular precipitates is depleted in chromium, with dramatically lowers the corrosion resistance. Sensitization can occur either during weld fabrication or in subsequent service operation.

- (a) intergranular cracking
- (c) intergranular cracking

- (b) intergranular cracking
- (d) sensitized material

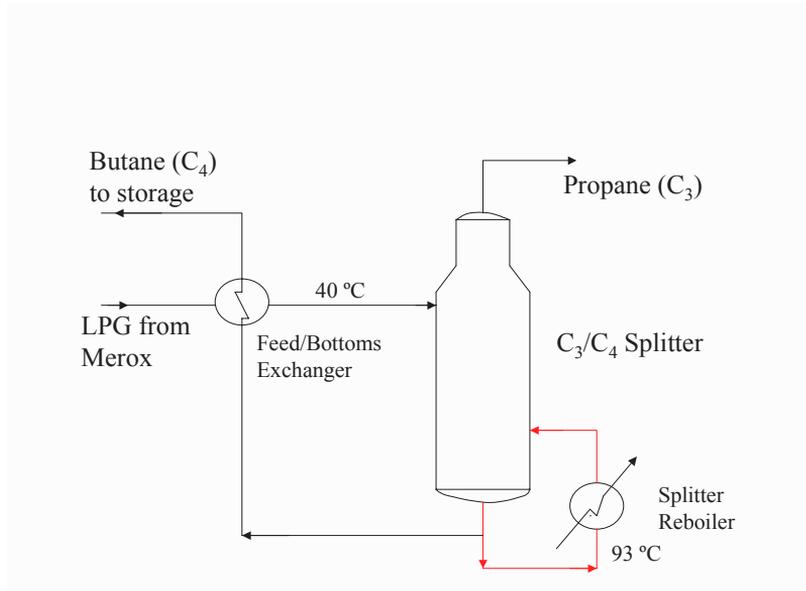
The carbon steel piping (ASTM A53 grade B) and equipment of the system (heat exchangers and splitter) were not originally stress relieved. The failure location was apparently from the weld, close to the 6 o'clock position, near a drain point. While preparing the original elbow for re-welding, plant inspectors noticed that there were transverse cracks within the heat affected zone of the weld. It was therefore decided to replace both elbows and locally stress relieve. As the carbon steel line was not stress relieved and an incident of caustic carryover had occurred a short time before the failure, inspection personnel began to suspect that caustic stress cracking might be the cause of the elbow failure. The equipment had been in service since 1972, but it was suspected that occasional caustic carryover incidents may have started following upgrade of another refinery unit in 1995. The stream temperature downstream of the C3/C4 splitter (Fig. 5) is 93 °C and approximately 15 wt% caustic is used in the Merox unit.

Fig. 5: simplified flow diagram of LPG Splitter

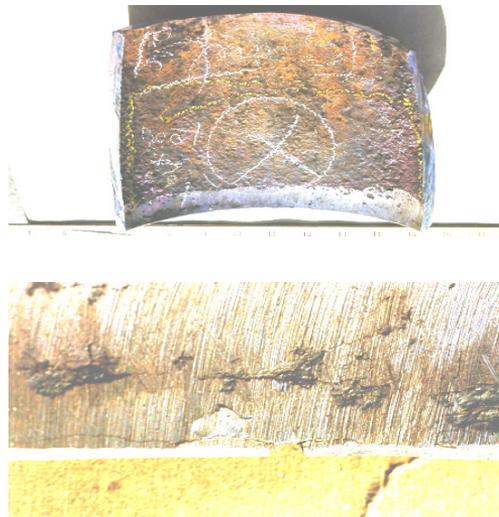
Fig. 6 shows the portion of the elbow received for investigation. In the weld preparation area, networks of transverse cracks were clearly visible under low power examination (Fig. 6, bottom). Microsections were taken transversely across the cracks. Branched intergranular cracks were noted (Fig. 7), which were filled with dark grey corrosion products. The elbow was a low carbon steel composition (0.11%C, 0.47%Mn, 0.22% Si, 0.034%P, 0.021%S). Energy Dispersive Spectroscopy microanalysis of the opened surfaces of one crack revealed mainly iron and oxygen, with significant levels of sodium also present. This confirmed that the cracks were filled mainly with iron oxides and the detection of sodium is consistent with caustic carryover into the piping downstream of the Merox unit. These findings confirm that caustic stress corrosion cracking was responsible for the elbow failure.

Fig. 6: elbow section
Top: as received
Bottom: view of cracking

1. Caustic stress corrosion cracking was confirmed within the heat affected zone of the carbon steel elbow.
2. Internally inspect both the splitter and reboiler by WFMPPT at the next shutdown.
3. Plan to replace the present piping with stress-relieved piping during the next shutdown.

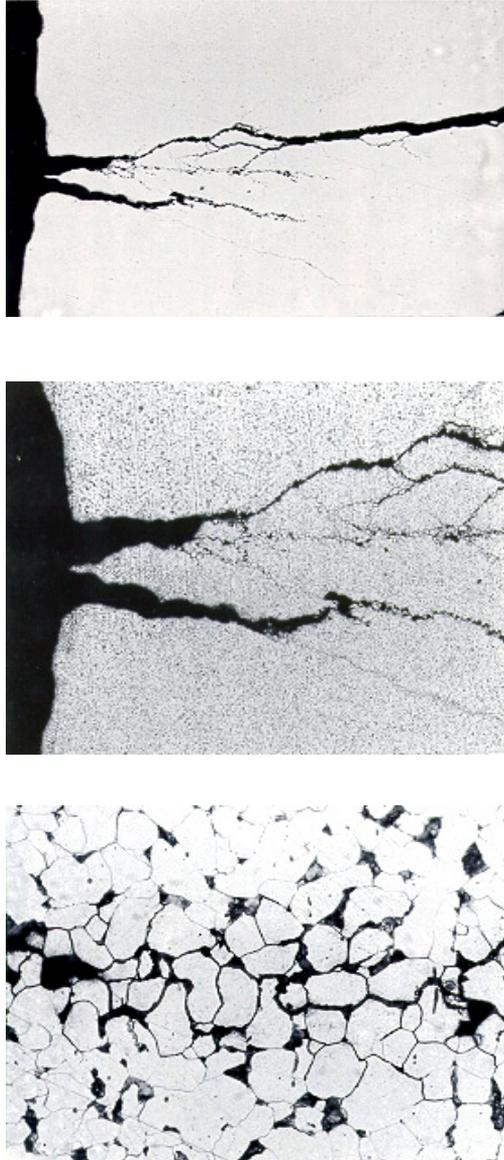
Fig. 7: microsections
top unetched x16
centre etched x32
bottom x400
