Comparative performance of turbine blades used in power generation: Damage vs. microstructure and superalloy composition selected for the application

H.M. Tawancy*, Luai M. Al-Hadhrami

Center for Engineering Research, Research Institute, King Fahd University of Petroleum and Minerals, Box 1639, Dhahran 31261, Saudi Arabia

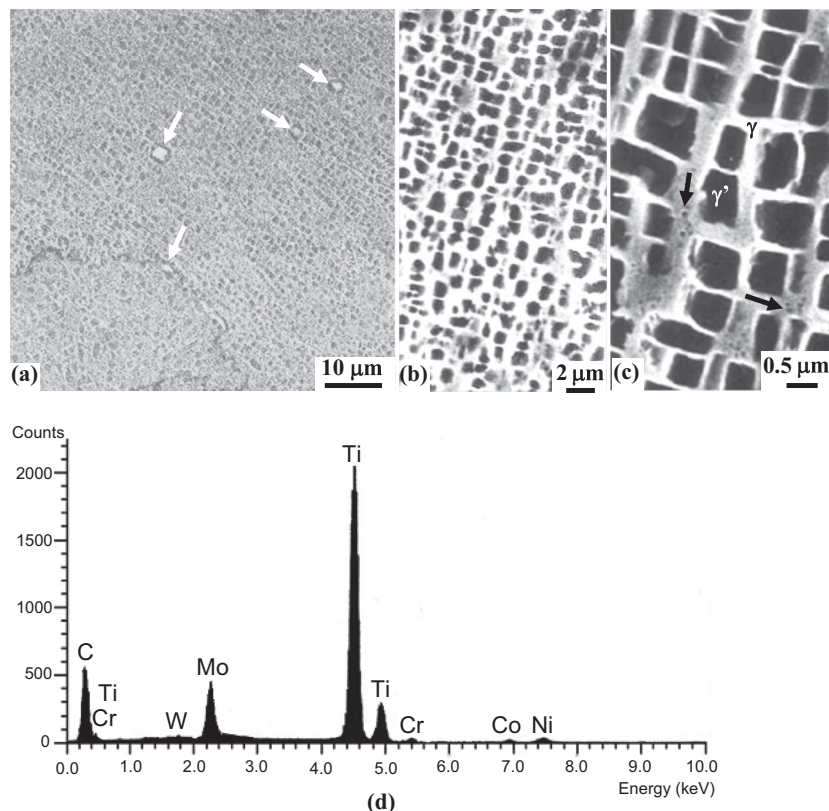
Fig. 1 summarizes characteristic microstructural features of unused blade made of alloy 520. The gross grain structure is shown in the backscattered electron image of Fig. 1a. Primary MC carbide particles within the matrix phase and at grain boundaries are indicated by the arrows. A secondary electron SEM image illustrating the morphology of the γ' -phase is shown in Fig. 1b. The cubical γ' particles precipitated by the aging heat treatment are observed to have a size ranging from about 0.5 to 1 μm . As can be seen from Fig. 1c, the finer cooling γ' particles have a spherical morphology. Fig. 1d is a representative energy dispersive X-ray spectrum illustrating the elemental composition of the MC carbide observed in Fig. 1a. As can be seen, the composition of appears to be consistent with a carbide of the type $(\text{Ti}_{0.8}\text{Mo}_{0.2})\text{C}$ [4].

Fig. 1. Characteristic microstructure of unused blade made of alloy 520. (a) Backscattered electron image of the gross microstructural features; MC carbide particles are indicated by the arrows. (b) Secondary electron SEM image showing the microstructure of the cubical γ' -phase. (c) A magnified image showing the cooling γ' as indicated by the arrows. (d) Energy dispersive spectrum illustrating the elemental composition of the MC carbide observed in (a).

known that primary MC carbide such as that shown in Fig. 1a is thermodynamically metastable and tends to decompose into the more stable $M_{23}C_6$ carbide during exposure at elevated temperature [4].

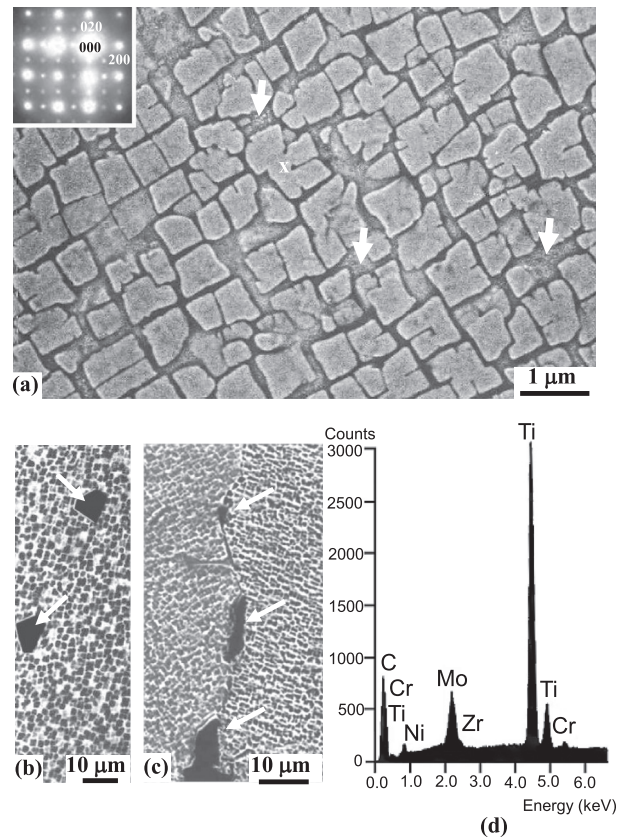
Typical microstructural features of unused blade made of alloy 720 are shown in Fig. 2. The cubical γ' -phase is shown in the bright-field STEM image of Fig. 2a with a size mostly less than 1 μm . A $\langle 001 \rangle_{\text{fcc}}$ microdiffraction pattern derived from the particle marked (x) is shown in the inset. Characteristic reflections of the L_{12} superlattice are observed at $\{100\}$, $\{110\}$ and all equivalent positions. Similar to the case of alloy 520, the primary MC carbide shown in Fig. 2b and c appears to be of the type $(\text{Ti}_{0.8}\text{Mo}_{0.2})\text{C}$, however, it contains a small concentration of Zr as observed from the spectrum of Fig. 2d. As shown in Table 1, alloy 720 contains some Zr in contrast with alloy 520, which is Zr-free. Consistent with the composition of alloy 710 (Table 1), the primary MC carbide is found to be similar to that in alloy 520. A secondary electron SEM image illustrating

Fig. 2. Characteristic microstructure of unused blade made of alloy 720. (a) Bright-field STEM image of the cubical γ' -phase; the arrows point at the cooling γ' and the inset is a microdiffraction pattern derived from the particle marked (x) in $(001)_{\text{fcc}}$ orientation. (b) And (c) are secondary electron SEM images showing MC carbide particles in the matrix and at a grain boundary respectively. (d) Energy dispersive spectrum illustrating the elemental composition of the carbide observed in (b) and (c).

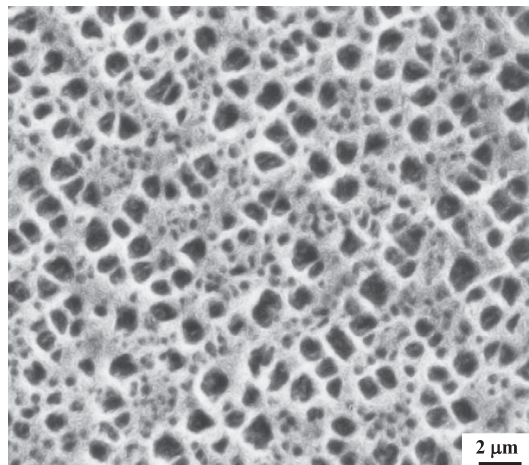
the morphology of γ' -phase in the blade made of alloy 710 is shown in Fig. 3. It is observed that the γ' structure is rather coarser than that in the blades made of alloys 520 and 710. Also, the respective morphology is not quite cubical, which can be related to the relatively large particle size.

Fig. 3. Secondary electron SEM image illustrating the microstructure of the cubical and cooling γ' in unused blade made of alloy 710.

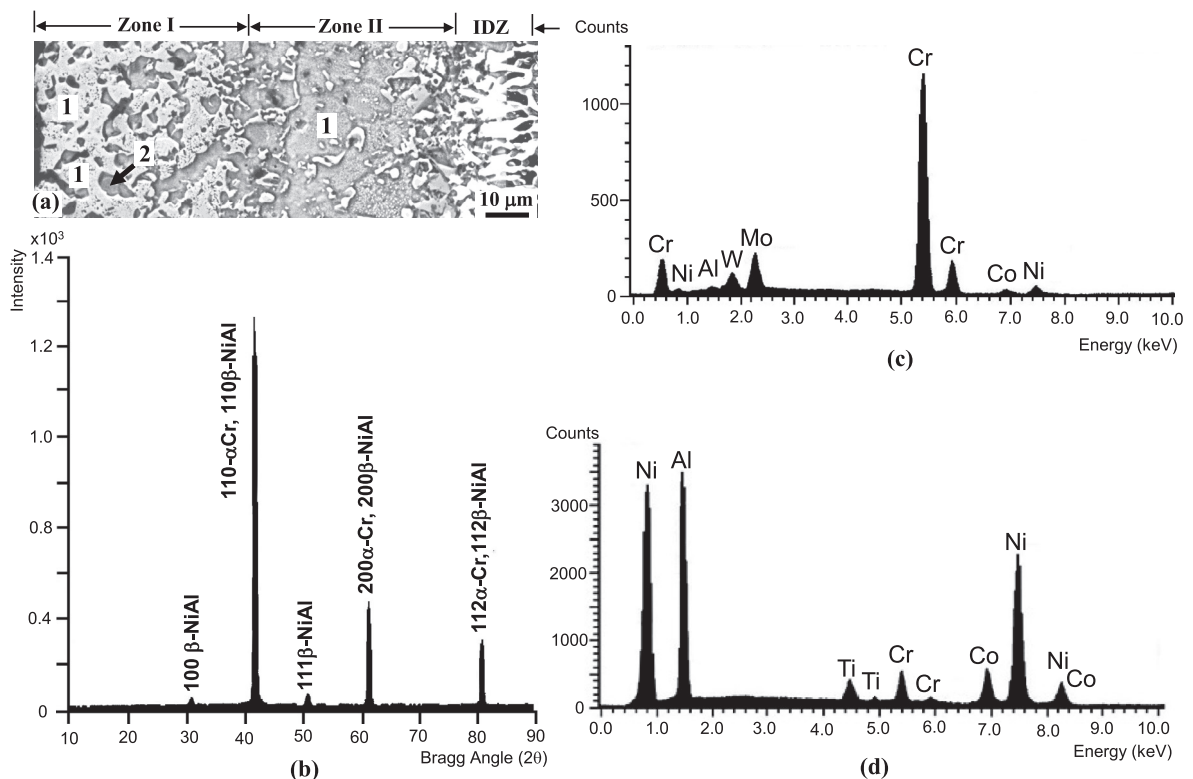
As an example, Fig. 4 summarizes typical microstructural features of the Cr-modified aluminide coating on the unused blade made of alloy 520. It is observed from the backscattered SEM image of Fig. 4a that the coating consists of two distinct zones followed by an interdiffusion zone (IDZ). The predominant constituent of zone I is α -Cr (body-centered cubic (bcc); $a = 0.2885$ nm) containing islands of β -phase based upon the NiAl composition (cubic B2-type superlattice; $a = 0.2887$ nm) as can be concluded from the X-ray diffraction of Fig. 4b and energy dispersive spectra of Fig. 4c and d. Since the lattice constants of α -Cr and β -NiAl are quite similar and because the disordered structure of β -NiAl is bcc, the characteristic reflections of the bcc structure of α -Cr coincide with the fundamental reflections of the ordered β -NiAl (Fig. 4b).

Fig. 4. An example derived from unused blade made of alloy 520 to illustrate the characteristic microstructural features of Cr-modified aluminide coating. (a) Backscattered SEM image along a cross-section of the coating and into the substrate. (b) X-ray diffraction pattern derived from the coating surface. (c) Energy dispersive spectrum illustrating the elemental composition of α -Cr in the outer coating layer (regions marked 1 in (a)). (d) Energy dispersive spectrum illustrating the elemental composition of β -phase (regions marked 2 in (a)).
